# VW Transporter - Driveshaft failure

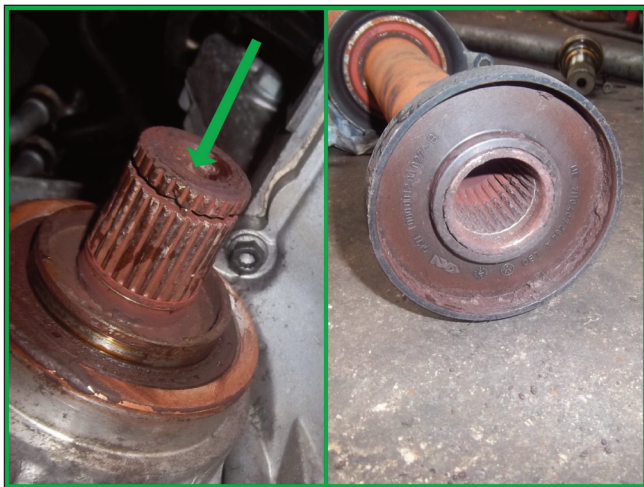
Arriving at our doors on the back of a low loader, we checked out the problem to discover it was something we had come across a few times before. The offside driveshaft had failed where it connects to the small adapter, which fits into the gearbox. This is a splined joint and the splines had completely sheered off.

This problem is apparently due to the joint not being greased and allowing wear to take place. The shaft and input adapter are sold as separate units from the main agent and cost

**The splined were dry and worn, the adapter shaft is held in place with an Allen bolt down the centre**

around €680. From the Factors the complete kit can be purchased from around €210, making this a cost effective option. The kit contains the short adapter, the full driveshaft and the hub nut.

Once the drive shaft is removed, the small drive adapter is held into the gearbox using an Allen bolt secured in the centre of the unit. Once this is removed, the adapter can be pulled from the gearbox.
