Xsara Picasso - Oil stain after new clutch

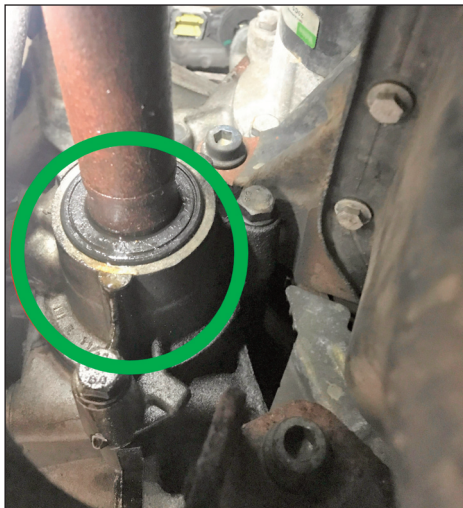
I suspect that the garage that carried out the job didn't remove the offside driveshaft. This means that when the gearbox is put back into place, it can

press against the seal if it has not been lined up perfectly. I always take the longer route doing this job, as it saves time in the long run when relocating the gearbox.

The new leak on this Picasso was gearbox oil and it was coming from the offside driveshaft seal. As the leak had only occurred after the clutch job, it was pretty certain that the seal had been damaged during the process of replacing the clutch.

The oil seal had only begun to leak after the clutch had been replaced

I did work out a fair price for the replacement of the seal, but I suspect that the owner was about to go and try to get the original garage to put right the problem.
