# Zafira with a persistent lean fault

This Zafira came into the workshop with a continuing issue of P0171 (System Too Lean (Bank 1)) trouble code. It had been previously diagnosed, with Lambda sensor 1 identified as the culprit. The sensor was replaced, and the system reset. A short road test revealed the same pending code P0171, and the long-term fuel trim was showing a high positive reading of 15% at engine idle.

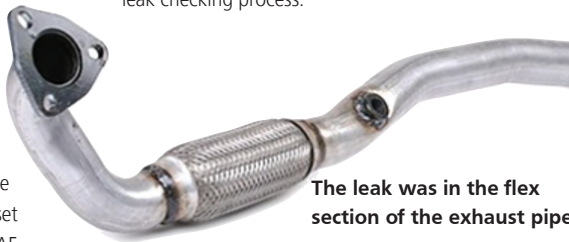
**The leak was in the flex section of the exhaust pipe**

There were no obvious exhaust leaks, so we decided to smoke test the system from the tailpipe. We used the Thinkcar PLD212. The Thinkcar has a higher-pressure output, 16 psi, compared with most

other smoke machines. Within seconds, we discovered a leak in front of the lambda sensor. We replaced the front section of the exhaust system, cleared emissions related data, and road tested the vehicle.

The Long-term fuel trim values had settled to 1.5% with the engine at idle, and there were no pending codes logged in EOBD.
