Opel Astra: Clicking noise from right A pillar when driving

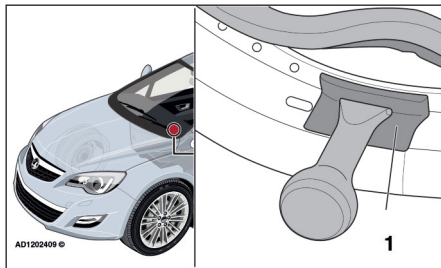
Question: A customer of ours is complaining that their 2010 Astra is making a clicking noise from the RH A pillar area when driving. We have heard the clicking noise on a road test, but we have been unable to find the source of the clicking noise in the workshop. Is this a known fault?

Answer: Yes, the clicking noise is known to us on the Astra built between 2010 to 2012. The noise is due to movement between the door sill panels. Remove the trim panel from the right front door sill. Partially remove the front door aperture weather seal. Apply a protective strip to area indicated Fig.1.1. Using

a hammer and a suitable tool (panel beating tool), increase tension in the bodywork joint. Refit the door aperture weather seal. Refit the trim panel to right front door sill. Carry out road test to ensure the clicking noise has been rectified.
