Jaguar XF: Vibration from LH front of vehicle when steering on full lock

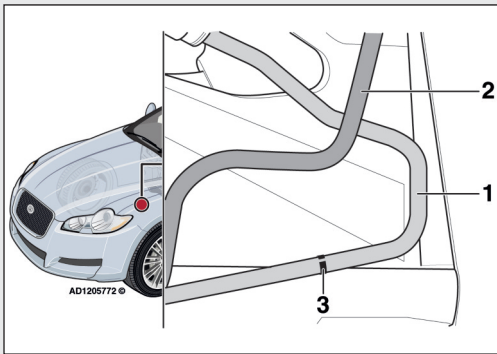
Answer: Yes, the fault you describe has been reported before on XF models with 2.0 petrol engines. The cause of the rattling noise is due to contact between the fuel feed pipe and the LH front wheel arch lining. Locate the fuel pipes behind the LH wheel arch lining. Re-route the plastic fuel pipe behind the braided fuel pipe Fig.1.1 & Fig.1.2. Fit clip to retain the fuel

pipe in the new position Fig.1.3. Refit the LH wheel arch lining. Ensure suitable clearance between fuel pipe and wheel arch lining. Carry out road test to ensure noise has been eliminated.
