# Land Rover Discovery 4: Lack of power

## Troublesome tees causing a lack of power

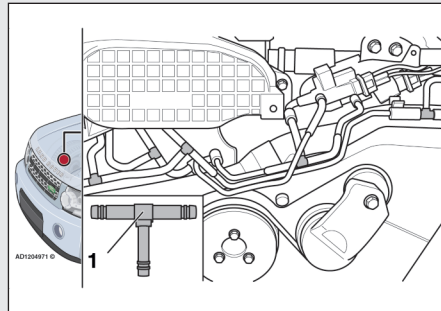
**Answer:** Yes, we are aware of a fault that affects 2011 model year Land Rover Discovery 4 and Range Rover Sport models with 306DT engine code. The fault is due to the turbocharger (TC) wastegate regulating valve vacuum pipe tee becoming blocked. Renew all the tee pieces, available from Land Rover parts department, in the turbocharger

(TC) wastegate regulating valve vacuum pipe  
Fig.1.1. Erase trouble codes and carry out road test to ensure the fault has been rectified.
