# Volkswagen Golf - Poor throttle response

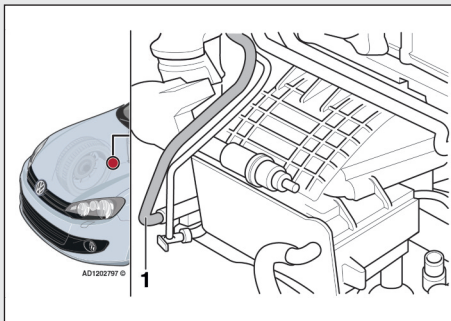
**Answer:** Yes, from the symptoms you have described, the fault is likely to be due to the crankcase breather hose rubber insert causing the hose to separate at its connection point. This fault affects several Volkswagen models with CAXA engine code. Locate and inspect the crankcase breather hose (Fig.1). If the crankcase breather hose is disconnected, fit a modified crankcase breather hose,

available from Volkswagen parts department. Erase trouble codes and carry out road test to ensure faults have been rectified.
