VW Polo: Rear window drops abruptly when opening

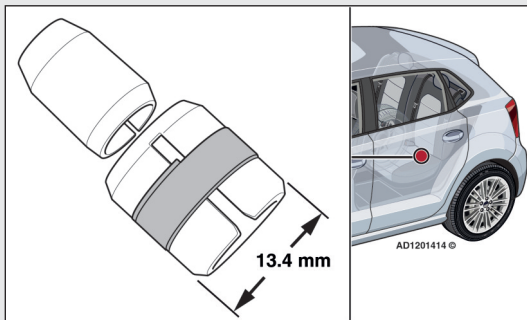
Answer: The door window glass repeatedly becoming detached from the window winder mechanism is a fault known to us. It is due to the door window glass locating bush being dislodged or faulty. Remove the rear door trim. Remove the rear door window glass. Check the door window glass for damage and replace if necessary. Cut adhesive tape, available from Volkswagen parts department,

into 6 mm x 55 mm strips. Wrap a new door window glass locating bush, available from Volkswagen parts department, with adhesive tape to a diameter of 13.4 mm Fig.1.1. Fit the door window glass locating bush to the door window glass. Lock the locating bush in place with an expander pin. Refit the rear door window glass. Refit the rear door trim. Repeat procedure for the opposite side.
