Toyota Prius: Hybrid warning and engine malfunction light on

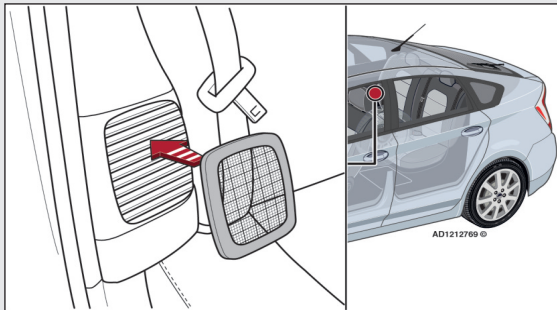
From the symptoms you have described, the fault is likely to be due to foreign objects and/or debris in the hybrid battery pack cooling fan that is reducing or stopping the air flow. Remove and clean the hybrid battery pack cooling fan. Replace the hybrid battery pack cooling fan if necessary. To prevent recurrence of the fault, fit a

hybrid battery pack air intake aperture filter (see figure 1). Check the operation and condition of the hybrid battery pack and replace if necessary.
