Golf MK V: Knocking when moving off or changing gear

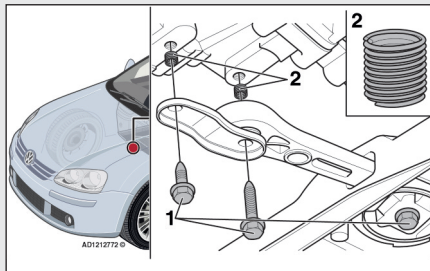
Question: We are struggling to find the cause of a knocking noise from the front of a 2006 Volkswagen Golf, when moving off or changing gear. We have checked the condition of the engine mountings, and they are all OK. Have you come across this knocking noise before?

Answer: Yes, we have come across this fault on several Volkswagen models with 02S transmission code. The noise is due to the bolts of the lower torque reaction link coming loose and damaging the bolt hole thread in the transmission housing. Remove and discard the bolts of the lower torque reaction link (see figure 1.1). Install thread inserts (available from Volkswagen parts department) to the

transmission housing (see figure 1.2). Fit the new bolts to the lower torque reaction link and ensure the bolts are tightened to the correct torque setting. Carry out a road test to ensure the knocking noise has been eliminated.
