Renault Clio: Clonking noise when moving off

Question: We have a 2010 Renault Clio 1.5 dCi in the workshop with a clonking noise from the front of vehicle when moving off or changing from forward direction to reverse direction. We have heard the clonking noise on road test, but we have been unable to find the source of the clonking

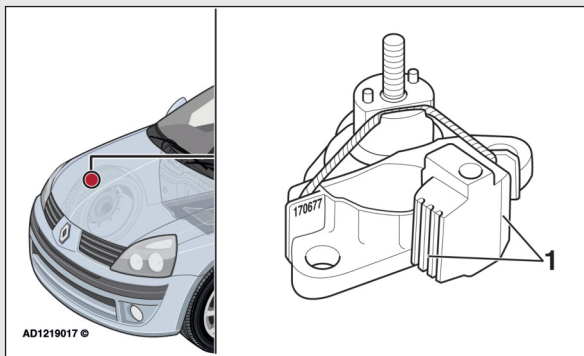
Answer: We are aware of this clonking noise you describe, and it is due to hardening of the engine mounting rubber and/or misalignment of the RH engine mounting. This fault affects Clio II models with K9K/F9Q engine codes. First of all, check the engine mounting for grooves (see fig1.1). Renew the engine mounting if no grooves are present. If renewing the engine mounting, do not refit

the plastic cover (if originally fitted). If retaining the existing engine mounting, remove and discard the plastic cover (if fitted). With the new or existing engine mounting in place, apply grease (Molykote) to the engine mounting grooves (see fig1.1). Move the engine backwards and forwards to align the engine mounting. Ensure engine mounting retaining nut/bolts are tightened to the correct torque setting. Carry out road test to ensure clonking noise has been eliminated.
