## Alternator pulley/bearing failure caused by water contamination on crankshaft pulley

### Ford Transit 2.2TDCi 2006-2012

Part Number affected: AEK2977

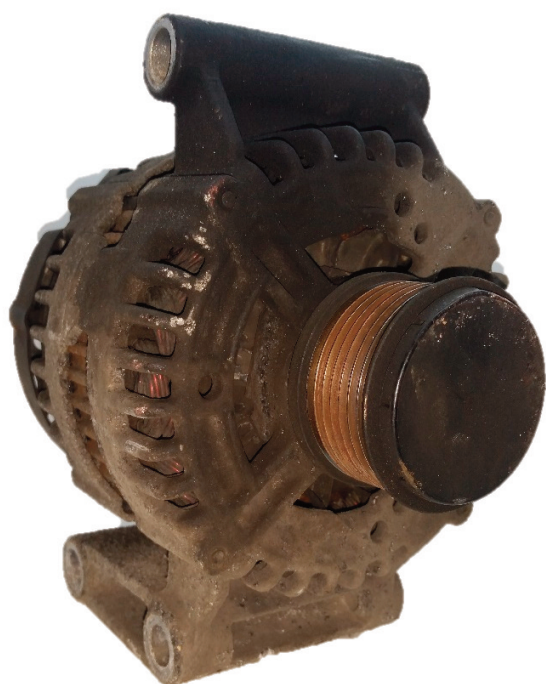
A known fault exists which can result in a charging fault and/or noise from the drive belt system. The fault occurs due to water and dirt contaminating the crankshaft pulley and causing it to fail. This results in excessive vibration within the drive belt system resulting in premature failure of the alternator pulley.

A contaminated and failed alternator

If the vehicle has this fault inspect the drive belt system and crankshaft pulley. It is recommended that the following are replaced:

Crank shaft pulley

Power steering drive belt and Alternator drive belt

It is recommended that a splash guard is fitted to avoid this failure occurring again. The fault will reoccur again if the above components are not replaced and a splash guard is not installed.
