Frank Massey, Autoinform

A Citroën Relay on and off again

A second-hand engine, a replacement gear box, and a new EGR valve and probably even more to consider. Autoinform's Frank Massey describes a Citroën Relay with some interesting problems, and the clues and fixes that eventually put the Relay back on the road for good.

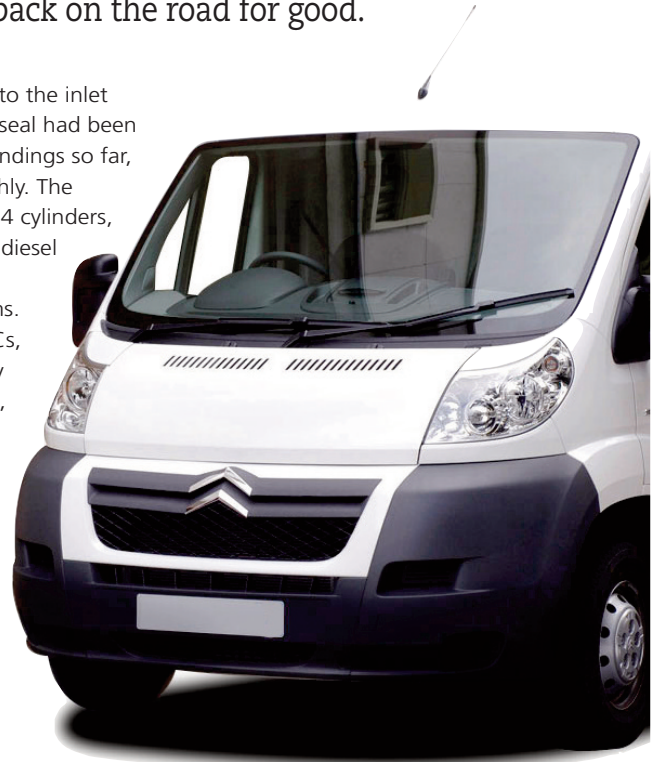
Some three weeks later, yet another call from the owner, describing what sounded like serious problems: lumpy engine, smoking and lack of power. Confident of my work so far, I suggested the sensible option of transporting it back to our workshop. Upon receipt, the only problem we discovered was a slight air leak from the plastic filter housing. As this was a suction system, a lack of fuel and cavitation would cause severe running problems. A complete new housing was fitted and fully tested with our ADS low pressure gauge. The gauge confirmed a perfect seal, and the status of the high pressure pump's ability to create a pressure differential across the filter housing.
