Frank Massey, Autoinform

Common Rail Diagnostics

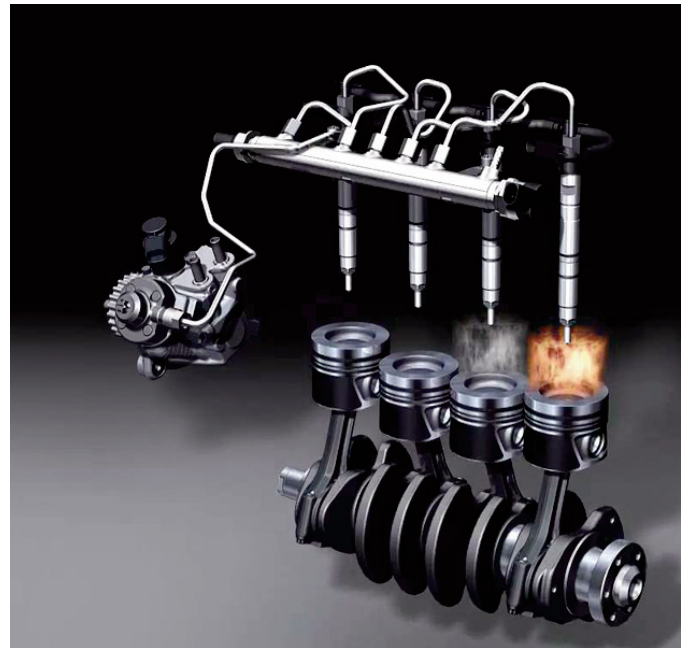
Rail pressure on a Bosch volume controlled system should reach 1.6v very quickly, with start capability anything over 1

volt from the rail pressure sensor. 1.3 volts represents approx. 300bar pressure. Injection can commence around 120 bar, so what was the problem?

The Pico trace demonstrated a very slow rise time and a voltage value just under 1 volt, with a nominal value of 0.5v, suggesting a low pressure priming, pressure generation or leakage problem. Once started the pressure was fine except the control duty cycle of the volume regulation valve was excessive, more open than normal. I checked the rail safety valve for leakage, then conducted an injector back leakage test. The No 2 (French 3) injector was leaking very badly. Given the cost of good replacement injectors, the owner declined the repair.
