Having a good process

If a car doesn't have any Diagnostic Trouble Codes (DTCs), does that mean that there isn't a problem? A long cranking Polo didn't have any DTCs, but there was obviously something wrong. Autoinform's Frank Massey explains his diagnostic process to get this Polo starting faster.

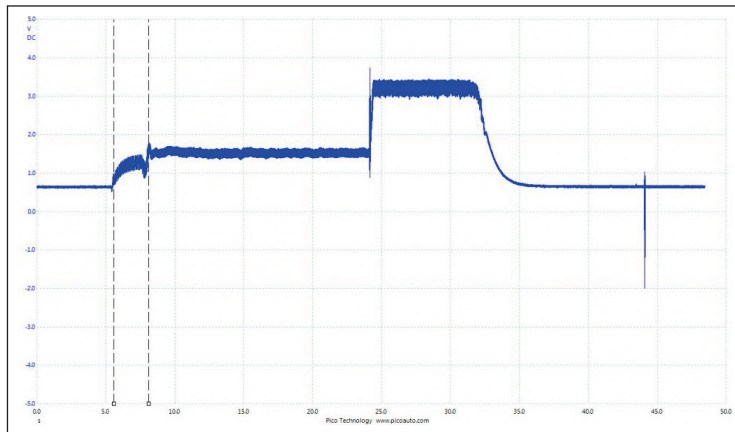
DELAY: The old pump took three full seconds to build pressure

Normally pressure build (I refer to this as rise time) should take no longer than 600 milliseconds and as little as 300 milliseconds – our vehicle took up to three whole seconds.

The most interesting aspect of our initial observations, unique so far for petrol systems, was that until a certain pressure was reached, no triggering of fuel or spark took place. We also noted that no driver outputs were present at the high pressure control valve, so no current was present either. This further confirmed our training group's findings that the valve is actually a volume control device. Proving this theory also follows our common rail pump proof process; removing current at 2,000 rpm immediately caused the pump to run at full pressure, 115 bar. The other intriguing part of the waveform profile was the accelerated decay time, not

normal for this pump type.

The decision? You need a new pump mate, with just one caveat – check the camshaft drive lobes and follower. Other non-relevant issues found included a reduced burn-time on coil three and no current transition across the wideband sensor.

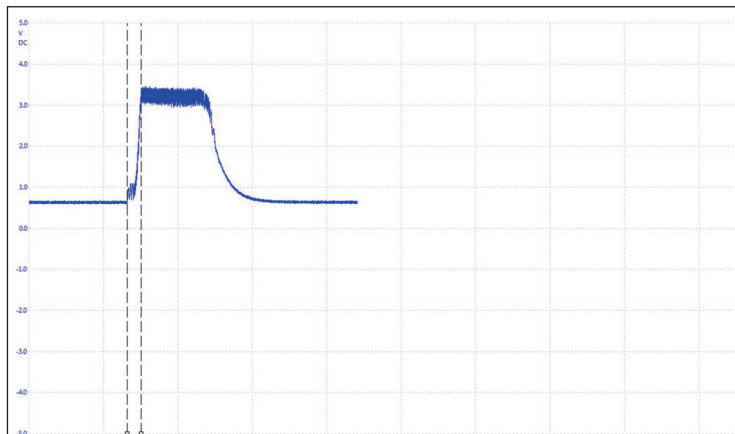
REPLACED: A new pump brought the figures back to the expected times

Replacing the pump reduced the rise time to 630 milliseconds. It was also noted via TPS that the pump had undergone several part number updates.
