Having a good process

Frank Massey, Autoinform

If a car doesn't have any Diagnostic Trouble Codes (DTCs), does that mean that there isn't a problem? A long cranking Polo didn't have any DTCs, but there was obviously something wrong. Autoinform's Frank Massey explains his diagnostic process to get this Polo starting faster.

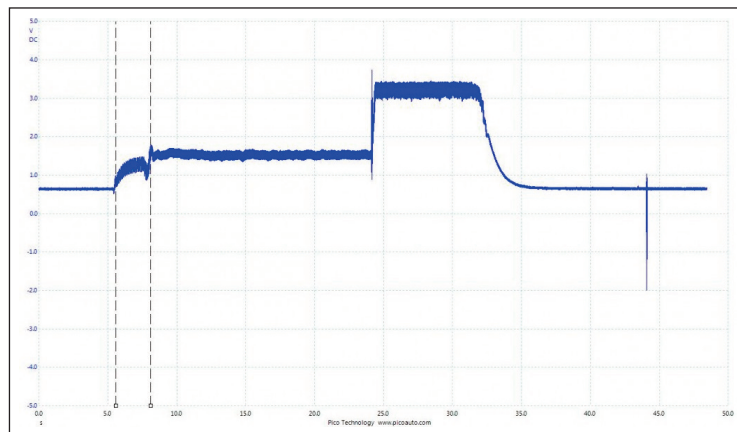
DELAY: The old pump took three full seconds to build pressure

Normally pressure build (I refer to this as rise time) should take no longer than 600 milliseconds and as little as 300 milliseconds – our vehicle took up to three whole seconds.

The most interesting aspect of our initial observations, unique so far for petrol systems, was that until a certain pressure was reached, no triggering of fuel or spark took place. We also noted that no driver outputs were present at the high pressure control valve, so no current was present either. This further confirmed our training group's findings that the valve is actually a volume control device. Proving this theory also follows our common rail pump proof process; removing current at 2,000 rpm immediately caused the pump to run at full pressure, 115 bar. The other intriguing part of the waveform profile was the accelerated decay time, not

The decision? You need a new pump mate, with just one caveat – check the camshaft drive lobes and follower. Other non-relevant issues found included a reduced burn-time on coil three and no current transition across the wideband sensor.

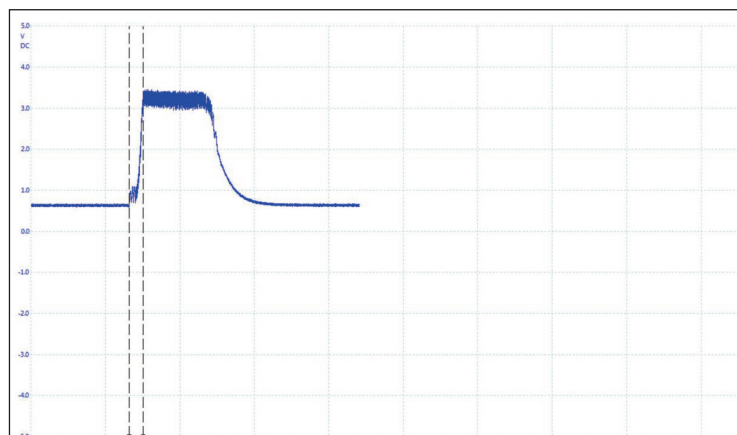
REPLACED: A new pump brought the figures back to the expected times

Replacing the pump reduced the rise time to 630 milliseconds. It was also noted via TPS that the pump had undergone several part number updates.
