# A Mazda without

# a spark

A Mazda MX-5 (MK2) was coming out of hibernation to enjoy the brief spring sunshine. The owner noticed that their pride and joy was not performing as well as it should. After a bit of tinkering, changing the spark plugs and the air filter, they decided to take it to a garage. Blue Print's Charles Figgins explains how he diagnosed and cured the Mazda.

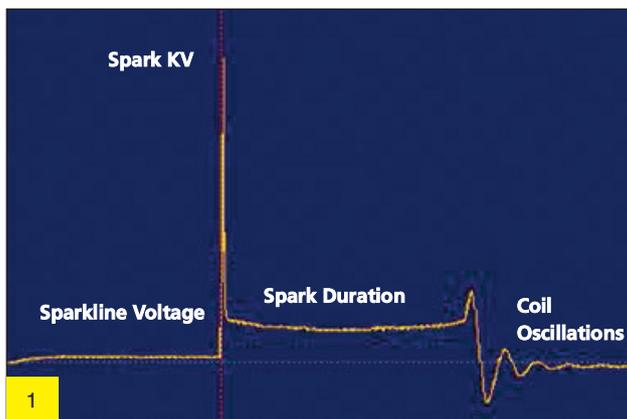
I started measuring the secondary ignition voltage with the G-Scan 2 oscilloscope with the HT lead adaptor (Blue Print part number BPT1057), mainly because of ease of access to the plug leads. On analysis of all four secondary ignition patterns at idle, all seemed OK (Figure 1).

**A normal secondary ignition pattern as seen on an oscilloscope**

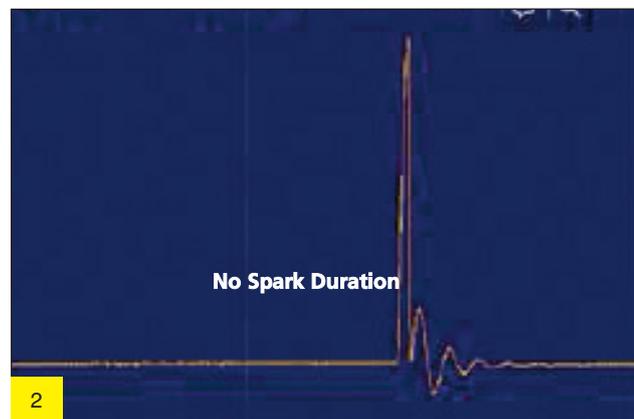
On doing this I noticed a slight misfire; measuring all four secondary voltage outputs again under this test, it was quite clear there

was an issue with No. 4 cylinder (Figure 2). All the ignition energy was being used for the initial jump

**There wasn't any spark duration in cylinder number 4**

across the spark plug gap, with nothing left to continue the spark duration. But what was causing it?

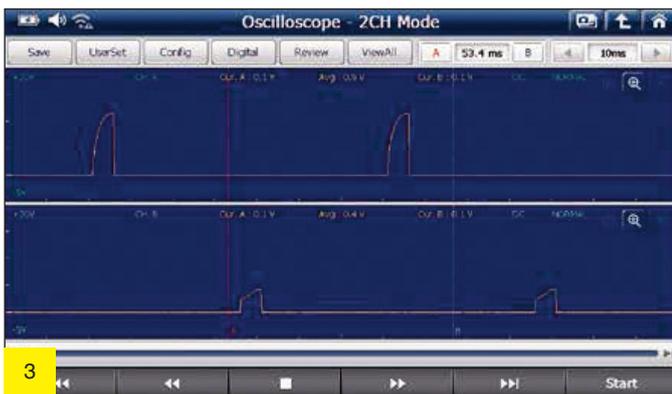
One advantage of having two separate coils is that you have one to compare against. First, I separated the connector for inspection; it was very clean and had no corrosion to cause a high resistance. I then used a break-out lead to save using back probes. I checked both the coils supply voltage and grounds under operating conditions - both were good. Then I checked the ECU trigger pulse and compared the signal for both coils. The pulse to the coil for cylinders 1 and 4 had a different pattern and a

**The coil pulse to cylinders 1 and 4, on top, had a higher voltage, as well as a different shape**

higher voltage (Figure 3).

As I was measuring between the ECU and the coils, I was measuring the voltage in a series circuit between two resistances. Did this mean I was looking at a high resistance on one of the coils?

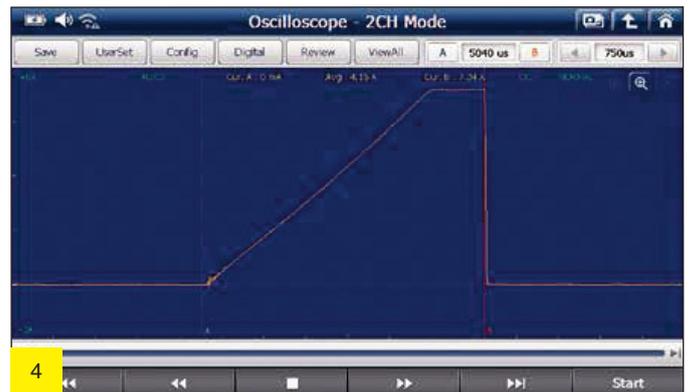
To prove this I measured the primary ignition current of both coils under load using the current clamp (Blue Print part number BPT1065), set to the 20 amp range. I measured the current on what I suspected to be the good coil for cylinders 2 & 3 first for reference (Figure 4).

the current to flow to charge the coil. On the oscilloscope pattern, it shows the current rising sharply to 7.24 amps. This shows that the coil is being charged quickly and is then flattening off as the coil is

**The coil for cylinders 2 and 3 charged up quickly to a maximum current of 7.24 amps**

saturated. It is then being controlled by the ECU and switched off abruptly to ensure a very quick collapse of the magnetic field that generates the secondary ignition voltage.

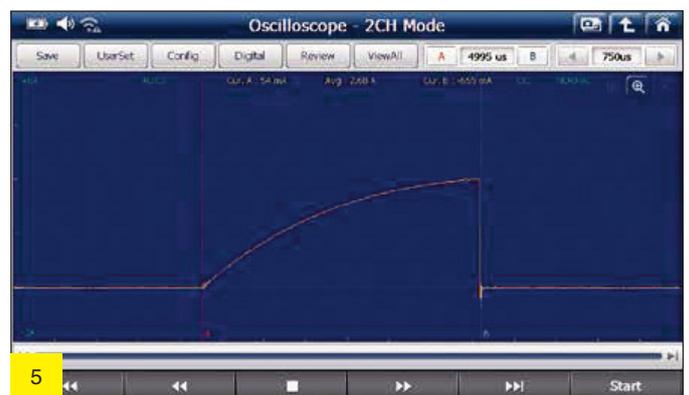
On measuring the suspected faulty coil for cylinders 1 & 4, the dwell time was the same, but the coil was slower to charge and it only had a peak of 4 amps. With this information I concluded that the misfire was due to a high resistance in the integrated driver end stage. With this affecting the primary circuit, it will then affect the secondary ignition voltage. Quoting ohms law, if you have a high resistance, less current will

**The coil for cylinders 1 and 4 charged up slowly, and only reached a maximum current of 4 amps**

flow (Figure 5).

I replaced the coils on the bracket (which come as a pair), carefully removing the old plug leads. The No.3 plug lead was seized in the coil due to corrosion. This did not show up in any of my electrical tests, which meant it had a good contact and any resistance was not affecting the secondary ignition on that cylinder. However, it meant I had to replace the plug leads as well.
