Alternator diagnostics for Opels with Isuzu Engines

There are some common faults associated with the charging system on Opel applications using the Isuzu 1.5 and 1.7 diesel engines. Blue Print gives some pointers to correctly diagnosis charging system faults prior to replacing the alternator, and to assist in the prevention of further problems.

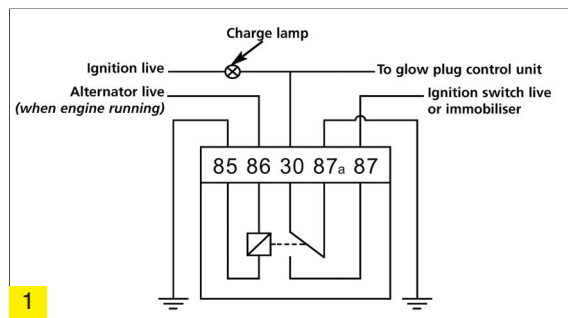
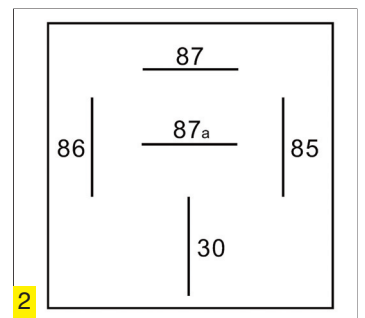
Wiring diagram for the charging lamp relay circuit, on left, and the relay itself, on right

(male connector, vehicle side) and will correspond to terminal 86 at the charge lamp relay. Alternatively, apply a fused feed directly to terminal 86 at the relay (under the same conditions) to eliminate a harness fault. (see figs 1,2 for relay circuit wiring diagram).

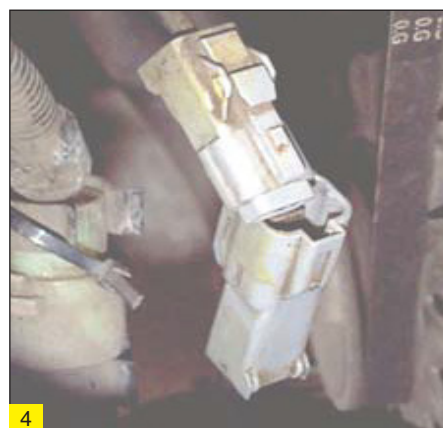
There are two common failure points. Firstly the large main alternator cable connector on the inner wing is very susceptible to severe corrosion (see fig 4). Partial contact here will restrict or stop alternator charge from reaching the battery, and in some cases cause the alternator to fail prematurely. This should be checked, cleaned or

replaced as necessary.

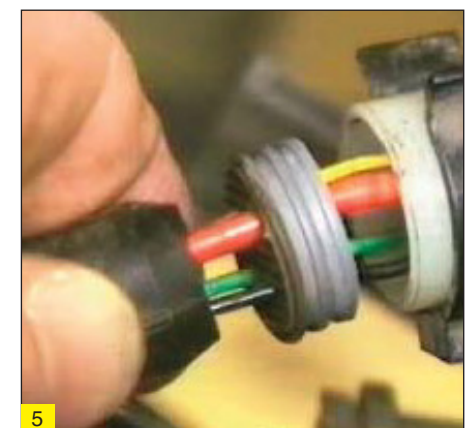
A quick and simple test involves separating the round 4-pin alternator loom connector (on the driver's side inner wing (see fig 5)). With the ignition on (and the immobiliser cleared, if applicable), give a fused positive feed to the relay energising wire. This wire is normally Yellow/Red
