Blue Print ADM561302

Mazda CX-30, CX-3, CX5 I & II, Mazda 2 III, Mazda 6 III & IV

Engines: 1.5d, 1.8, 2.2d

Alternator overrun pulley

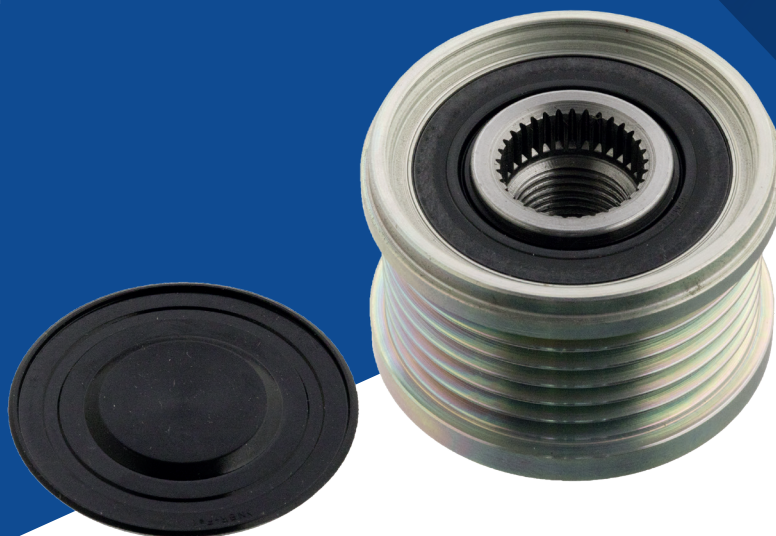
The vehicle becomes difficult to start and displays signs of overheating, and/or there is a 'squealing' noise from the area around the engine bay. The vehicle's instrument panel shows the error message "charging system malfunction - engine stop possible" and the alternator/charge lamp may also be illuminated along with the 'i-stop' lamp flashing amber. These failure lamps indicate that the battery is unable to charge sufficiently.

The alternator overrun pulley is designed to dampen vibrations that occur in the FEAD (front-end auxiliary drive) and should come to a smooth stop when spun. After a certain period of time, the bearing wears from the induced shock loadings - causing the pulley to seize. This in turn triggers the auxiliary belt to slip and delaminate, leading to the eventual breakage of the belt.

The auxiliary belt should be removed and the alternator overrun pulley inspected for rubber deposits in the ribs, caused by the belt slipping. Check the rotation of the overrun pulley - it should 'freewheel' and come to a smooth stop. Any feeling of bearing irregularities or seizure and the pulley should be replaced along with a new auxiliary belt. The water pump for this engine is driven by the auxiliary belt so continuing to drive the vehicle with a defective pulley and belt could cause catastrophic engine failure due to overheating. The battery and the alternator should also be tested and replaced if found outside of tolerances. Additionally, any fault codes in the engine control unit (ECU) should be reset.
