Spin Doctors - an overboosted L200

The Mitsubishi L200 pick-up is well known for its ruggedness and load lugging capabilities. The example in question is a 2003 model, which is regularly put to work pulling a mini digger in addition to other ground work duties. The vehicle had covered over 140,000 miles and was still going strong, except in certain conditions. Charles Figgins, Blue Print Technical Consultant, explains how he diagnosed and fixed the problem.

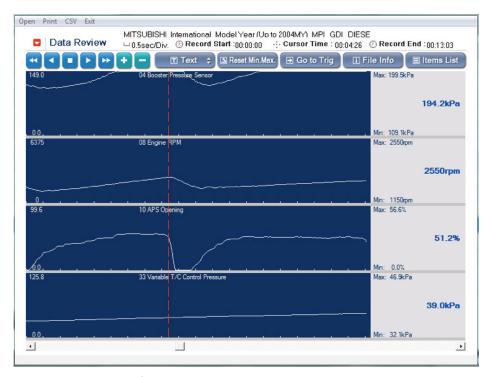
As the fault code told me there was an over boost problem but not much else, it was time for another road test. This time I plugged the vehicle into the G-Scan 2 and set it to record looking at the following values: Boost Pressure, Engine RPM, Throttle Position and Variable Turbo Charger Control Pressure (Figure A). Before the road test, the fault code was logged and cleared, then driven to replicate the fault.

When the vehicle was back at the workshop, I reviewed the data I had collected. First looking at the boost pressure reading, I discovered at several points it had exceeded its maximum boost pressure of 200kPa (2.0 bar). This was why the engine management lamp had come on, but what was causing it?

Figure A. Scope trace of road test data. Top to bottom: Boost Pressure Sensor, Engine RPM, Throttle Position and Variable Turbocharger Control Pressure

Looking closely at the road test data, the variable turbo charger control pressure seemed slow to react, but before I started condemning parts, I needed to check the system out and confirm what reading I was getting from serial diagnostics.

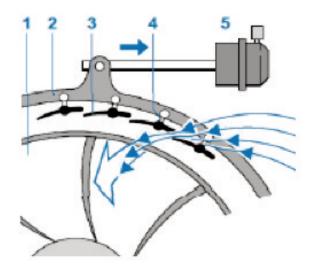
Fig. B At idle, on left, variable vanes direct exhaust to the ends of the vanes through small gaps, increasing turbo speed and boost. At higher engine speeds, at right, the vanes form larger gaps that direct slower moving exhaust to the base of the vanes, decreasing turbo speed and boost without the need for a wastegate. Parts are: 1) Turbine 2) Adjusting Ring 3) Deflector Blades 4) Adjusting Lever and 5) VG Actuator

The deflector blade angle is adjusted by turning an adjuster ring (Part 2 in Figure b). This then sets the deflector blades to the desired angle. On this L200, the adjuster ring is operated by an actuator which is controlled by solenoid valve, that is controlled by the engine ECU. Thus the turbo pressure can be adjusted to the optimum setting in response to a range of inputs.

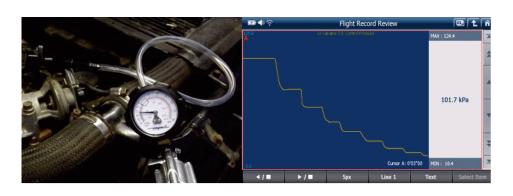
With a good vacuum supply and pipe work I ruled this out. I then checked the sensors to confirm the measurements I was getting. I unplugged the vacuum pipe from each sensor and connected a hand vacuum pump – this was to test each sensor and at the same time compare the readings to the ones I was getting from G-Scan 2 (Figure C).

With both the boost pressure and the variable turbo charger control pressure sensors confirmed to be OK and reading accurately, I checked the operation of the VG actuator. The VG actuator rod moved freely and the diaphragm showed no signs of leaking. Note: Do not apply more than 59kPa of vacuum to the diaphragm, otherwise damage may occur.

Fig. C The G-Scan was used to compare sensor readings to known values to verify ECU inputs.
