Spin Doctors

Written by Charles Figgins - Blue Print Technical Consultant

The Mitsubishi L200 pick-up is well known for its ruggedness and load lugging capabilities. The example in question is a 2003 model, which is regularly put to work pulling a mini digger in addition to other ground work duties. The vehicle has covered over 140,000 miles and was still going strong; until a few months back.

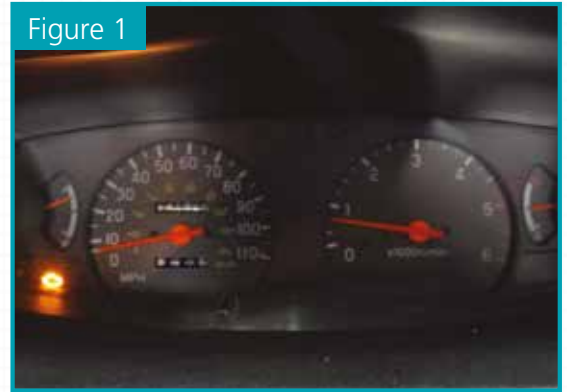
Figure 1

If the vehicle was fully laden and going uphill, the engine management lamp would come on and the pick-up would lose power – a few weeks later it was booked into the workshop. On initial inspection and after a road test it seemed to perform as normal, however, this was in an unladen condition. After finding a suitable hill to replicate the driving conditions, sure enough the engine management lamp came on (Figure 1) and the power went flat.

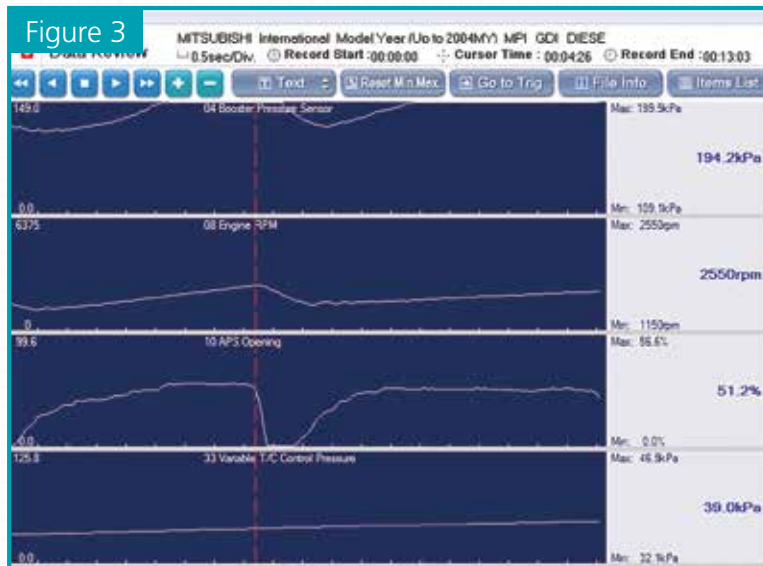
Figure 3

As the fault code told me there was an over boost problem but not much else, it was time for another road test. This time I plugged the vehicle into the G-Scan 2 and set it to record looking at the following values: Boost Pressure, Engine RPM, Throttle Position and Variable Turbo Charger Control Pressure (Figure 3). Before the road test the fault code was logged and cleared, then driven to replicate the fault.

When the vehicle was back at the workshop I reviewed the data I had collected. First looking at the boost pressure reading, I discovered at several points it had exceeded its maximum boost pressure of 200kPa (2.0 bar). This was why the engine management lamp had come on, but what was causing it?

Looking closely at the road test data, the variable turbo charger control pressure seemed slow to react, but before I started condemning parts I needed to check the system out and confirm what reading I was getting from serial diagnostics.

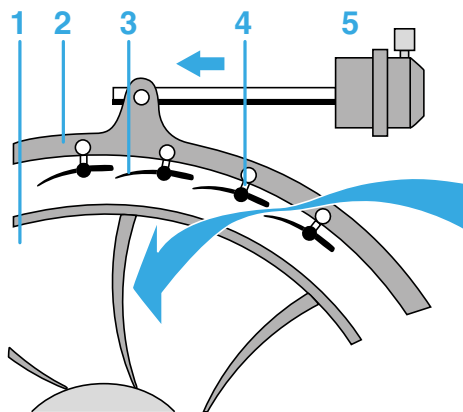
Figure 4

Deflector blade setting for high turbo pressure

Key:
 1. Turbine
 2. Adjusting ring
 3. Deflector blade

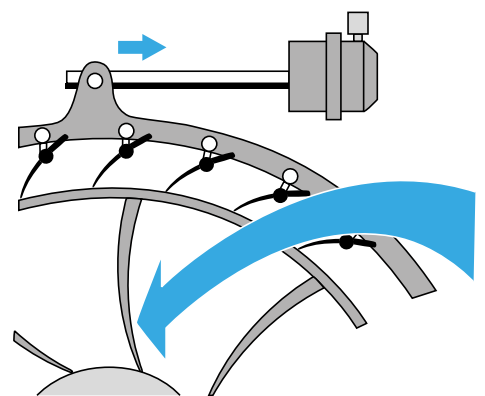
Deflector blade setting for low turbo pressure

4. Adjusting lever
 5. VG actuator

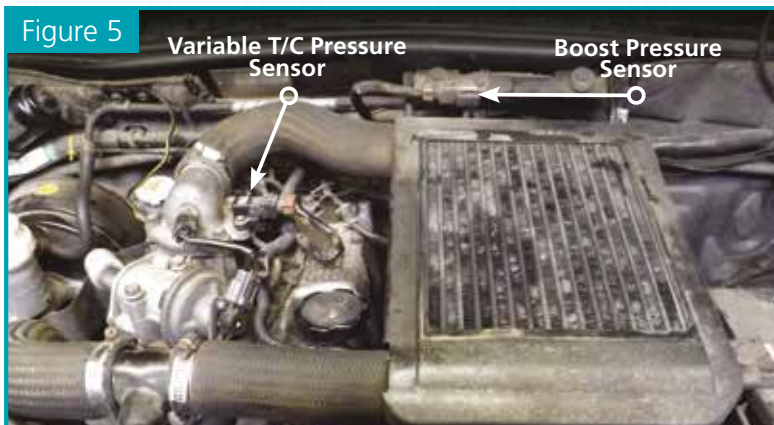
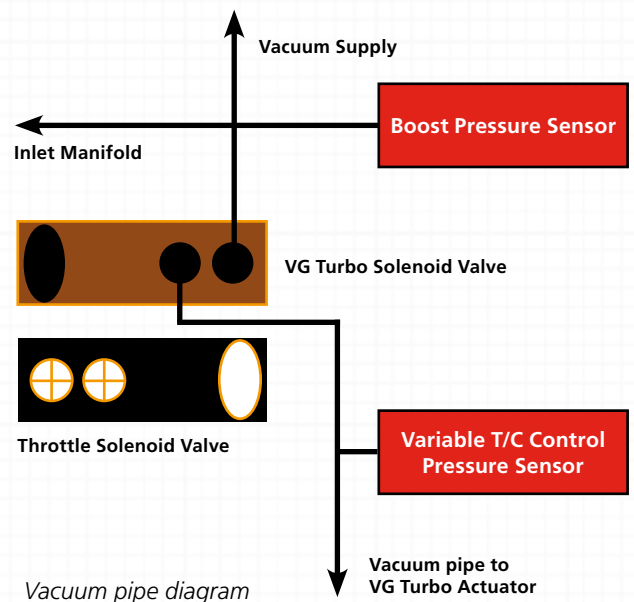
Figure 5

With a good vacuum supply and pipe work I ruled this out; I then checked the sensors (Figure 5) to confirm the measurements I was getting. I unplugged the vacuum pipe from each sensor and connected a hand vacuum pump – this was to test each sensor and at the same time to compare the readings to the ones I was getting from G-Scan 2 (Figure 6).

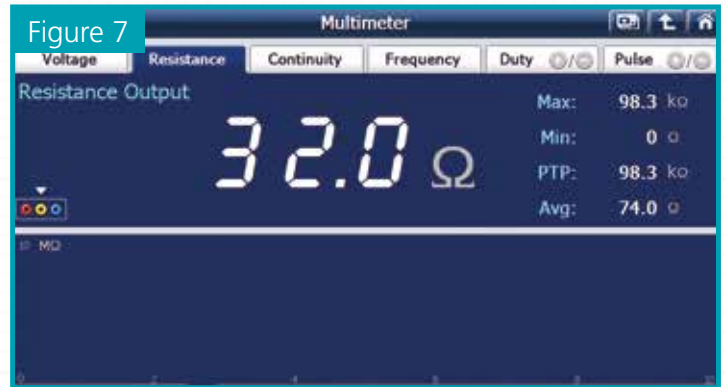
The reading was 32 Ohms; this was within the tolerance of (29-35 Ohms at 20C) (Figure 7).

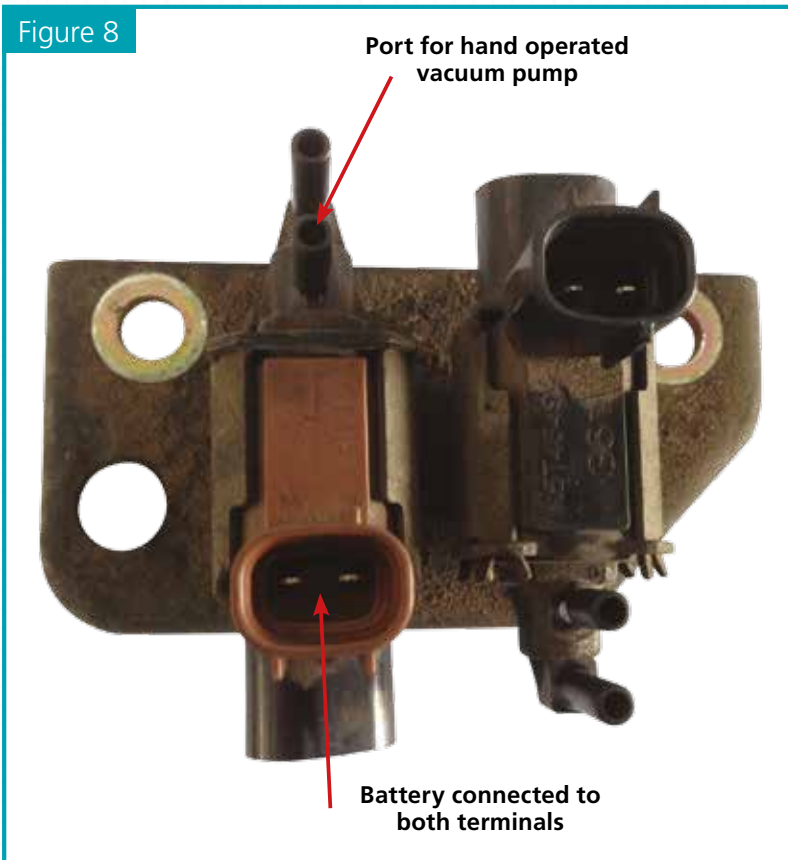
Figure 8

I then checked the operation of the solenoid (Figure 8).

With the solenoid powered up using a 12V battery and suitable connectors and a vacuum applied to the lower port, with the upper port sealed, the vacuum should be maintained. However, this solenoid valve was not quite holding its vacuum.

The way this valve works is that a vacuum is supplied to the upper port from the vacuum pump. When the valve is switched on by the engine ECU and controlled by PWM (Pulse Width Modulation), it opens the lower port to operate the VG actuator in order to move the deflector blades according to the engine load. This was not happening fast enough due to a slight internal leak on the valve, which made the turbo produce too much boost at the wrong time, resulting in the fault code '49 over boost', causing it to go into 'safe mode'.

After replacing the VG turbo solenoid valve, a road test and recording was required to test if the problem was fixed (Figure 9).

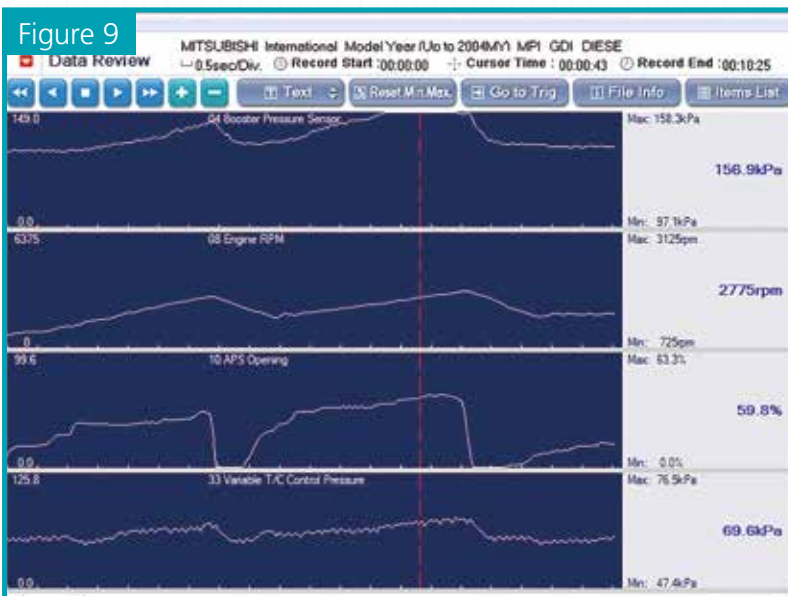
Figure 9

Looking at the data, compared to that of the first recording (Figure 3), the variable turbo charger control pressure is now showing that it is being controlled correctly and the turbo is no longer over boosting. The vehicle was back performing just as it should.
