Technical Bulletin

Product Information: ADA101413 Clock Spring

Applications: Chrysler Voyager and Grand Voyager

Date Issued: 03/2011

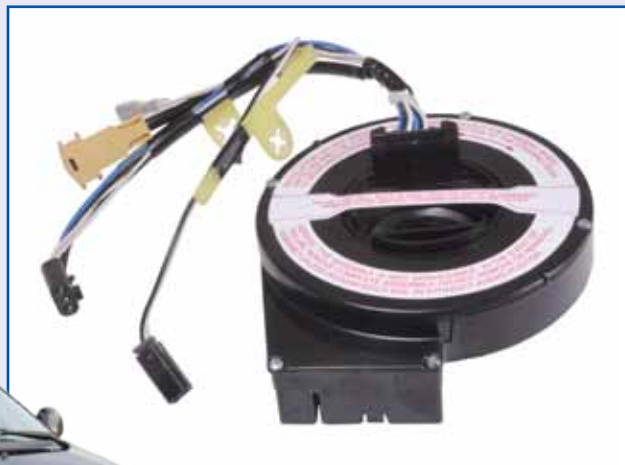
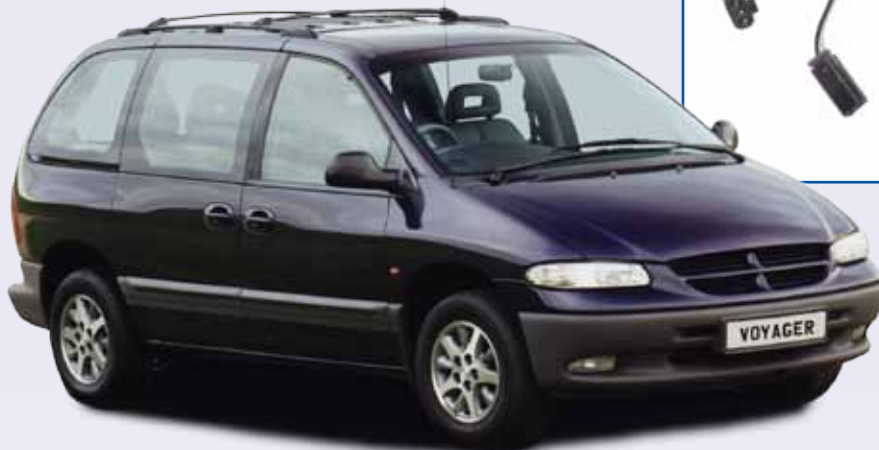
Malfunctioning of the clock spring (also known as Air Bag Squib) on the Chrysler Voyager and Grand Voyager models is not an uncommon problem, to the point that Daimler Chrysler issued a safety recall in the US in 2004 for this particular problem on models manufactured between 1996>2000, which affected as many as 1.2 million vehicles worldwide.

A clock spring allows a constant contact to be made between the stationary wiring loom on the steering column to the moving components on the centre of the steering wheel. This is done via coiled strip cables inside the clock spring that can fail through fatigue, rendering the steering wheel-mounted controls inoperable.

- Air Bag warning light intermittently or constantly illuminated or failing to illuminate when ignition is turned on
- Horn not working
- Cruise Control not working

Scanning for a Diagnostic Trouble Code (DTC) will usually discover a code that relates to 'Driver Squib Circuit Open' which will confirm that the clock spring is indeed faulty and requires replacing.
