Blue Print ADM58089, ADM58096

To fit:
Ford, Mazda and Volvo (various models)

Control Arm Bush

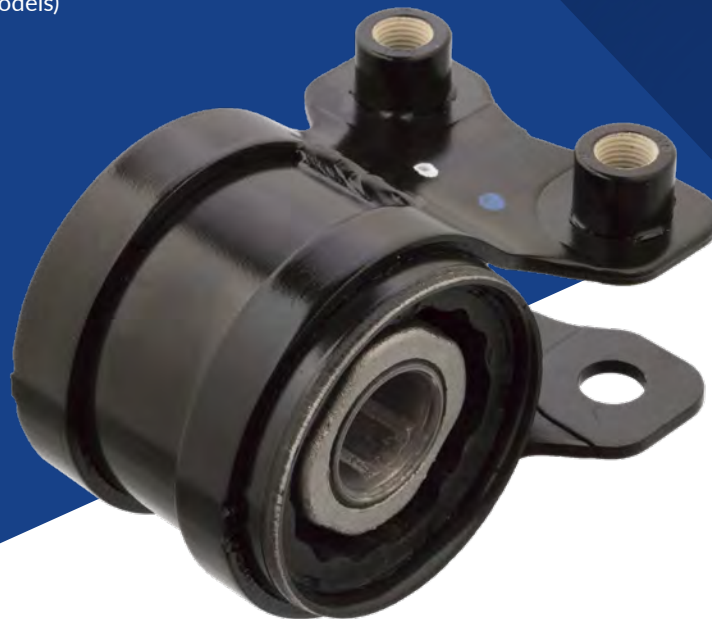
Uneven tyre wear and misalignment of the front suspension.

The lower suspension control arm bush is worn.

Blue Print provides an economical repair solution whereby the control arm bush can be replaced instead of the complete suspension control arm.

When replacing this bush it is important that the alignment of the original control arm bush is followed.

If the bush is not aligned correctly on the shaft of the suspension arm then there is a risk of premature failure and a shortened lifetime of the component.

Note: There is a special tool available from the vehicle manufacturer to assist in the replacement of the control arm bush. By using this tool it can be ensured that the installation position and press-fit depth of the bush will be correct.
