Technical Bulletin

Product Focus – Daewoo Matiz Distributor ADG014201

Date Issued: 01/02/07

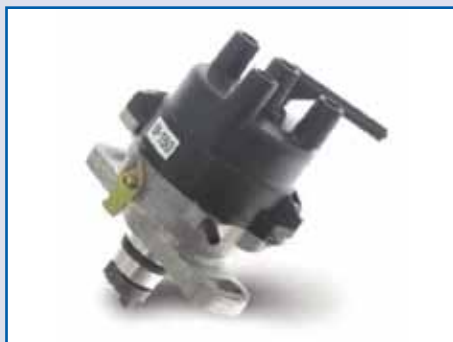
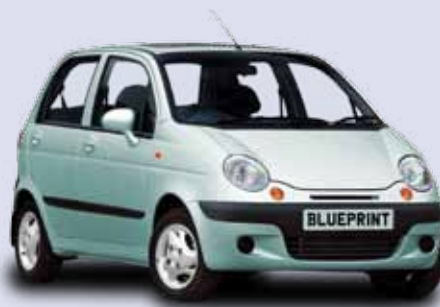
Blue Print is aware that the distributor assembly on the Daewoo Matiz (800cc) is prone to failure.

The fault originates from the ignition optical sensor mounted within the distributor, and is not available as a separate component from Chevrolet. If condemned, the distributor must be replaced as a complete unit (the Blue Print part will replace both the original Mando and DAC types).

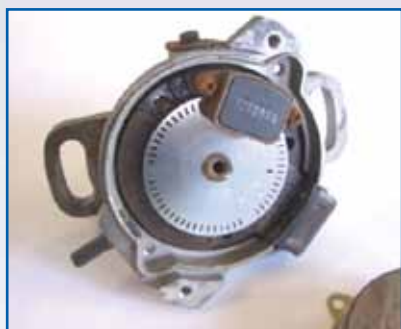
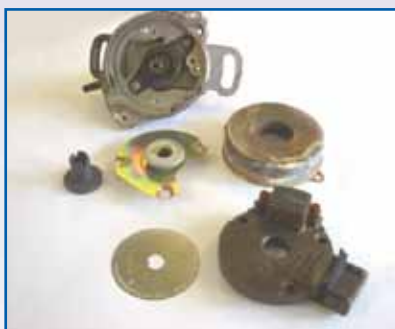
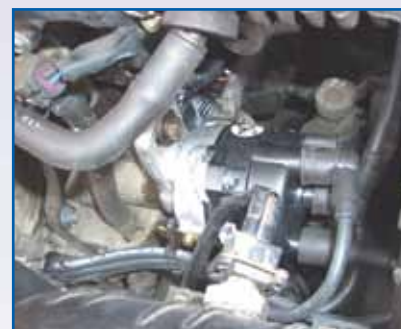
Symptoms may include erratic misfire, 'stuttering' or ignition failure. The MIL may illuminate as the misfire or stutter condition occurs, but will not remain on. The fault may also clear itself intermittently (e.g. after allowing the engine to stand for 5 minutes).

Diagnosis may be made by checking for DTC (Diagnostic Trouble Codes) using suitable equipment such as the Multiscan. Access is via the 12 pin GM/Daewoo diagnostic plug mounted under the glove box.

- Mark the position of the original distributor before removing to enable the replacement to be fitted approximately in the same position
- Be ready to catch residual engine oil which may leak out on removal of the distributor from the engine.
- Check/adjust the ignition timing after fitment (see note below)
