California Dreamin'

Written by Charles Figgins
- Blue Print Technical Consultant

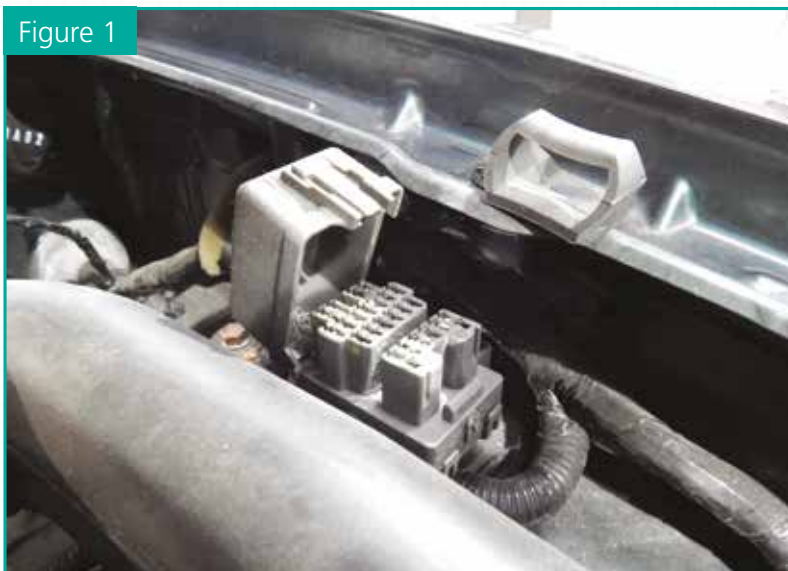
Figure 1

Before road testing the car I carried out a quick check for fault codes and had a look at any data that may give me a clue to the symptoms described by the owner. This car was not equipped with an EOBD (European On-Board Diagnosis) 16 Pin socket, so I had to use the Mazda 17 Pin connector (Blue Print part number BPTTE1022) on the G-Scan 2 to access the information I needed **Figure 1**.

The engine management had three fault codes stored; air mass, engine temperature and crank position sensor, which were all down to being unplugged and being plugged back in again in the past. All codes were stored on the G-Scan 2 for the owners report before erasing. On inspecting the four pages of data provided, there was nothing obvious as the engine idled quite happily.

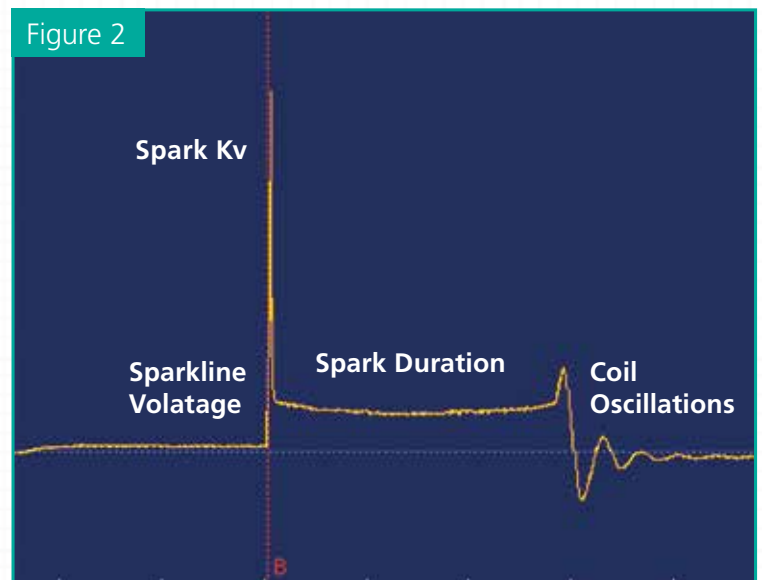
I started measuring the secondary ignition voltage with the G-Scan 2 oscilloscope with the HT lead adaptor (Blue Print part number BPT1057), mainly because of ease of access to the plug leads. On analysis of all four secondary ignition patterns at idle, all seemed OK **Figure 2**.

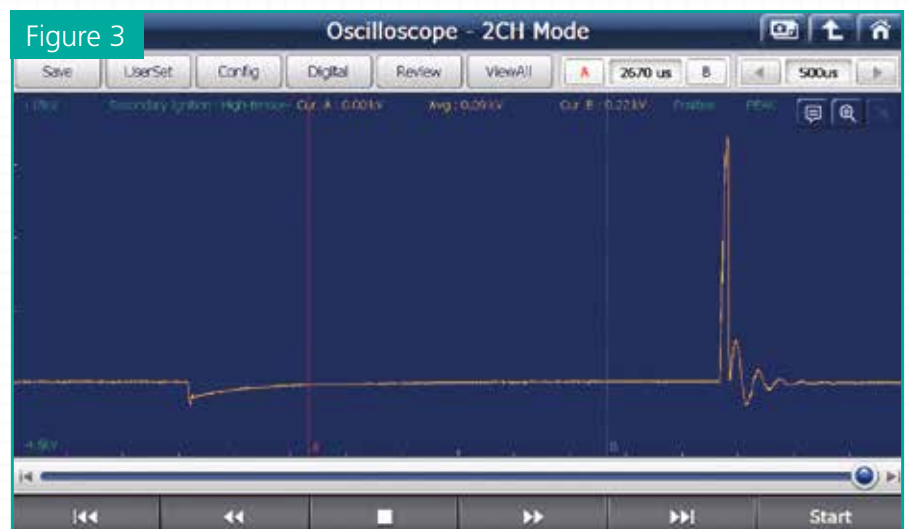
On doing this I noticed a slight misfire; measuring all four secondary voltage outputs again under this test, it was quite clear there was an issue with No. 4 cylinder **Figure 3**. All the ignition energy was being used to jump across the spark plug gap, with nothing left to continue the spark duration. But what was causing it?

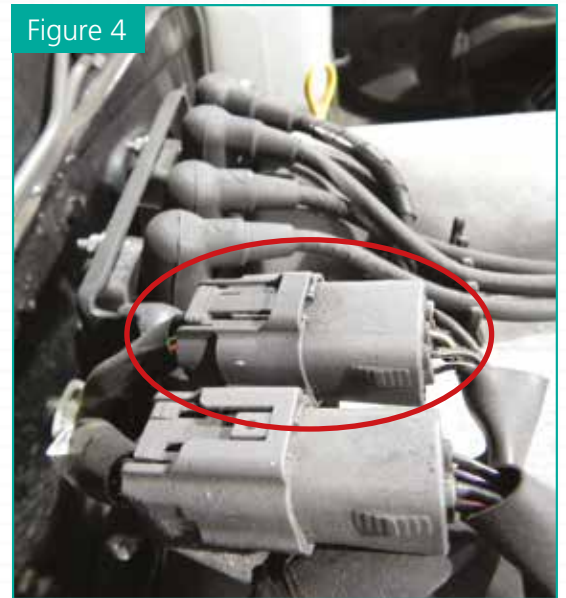
Figure 4

Turning my attention to the other side of the ignition coil, Mazda in their wisdom fitted the connector to both coils on top of the engine, making it nice and easy to access for testing **Figure 4**.

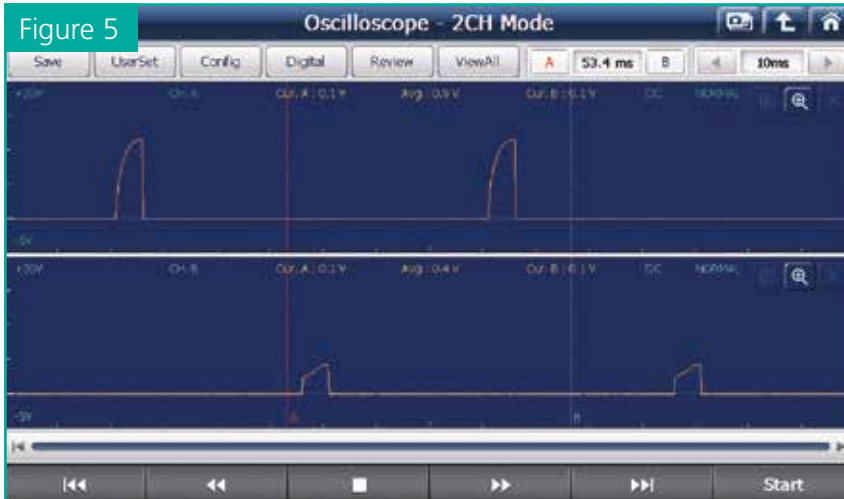
Figure 5

The advantage of having two separate coils is that you have one to compare against. First I separated the connector for inspection; it was very clean and had no corrosion to cause a high resistance. I then used a break-out lead to save using back probes. I checked both the coils supply voltage and grounds under operating conditions - both were good. Then I checked the ECU trigger pulse and compared the signal for both coils. The pulse to the coil for cylinders 1 and 4 had a different pattern and a higher voltage **Figure 5**.

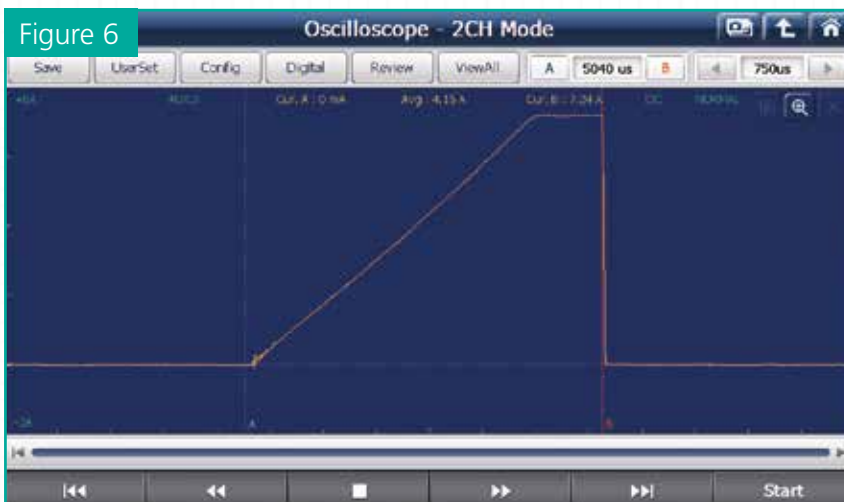
Figure 6

To prove this I measured the primary ignition current of both coils under load using the current clamp (Blue Print part number BPTE1065), set to the 20 amp range. I measured the current on what I suspected to be the good coil for cylinders 2-3 first for reference **Figure 6**.

The primary current is switched by the integrated driver end stage in this application. This provides an earth path to complete the circuit for the current to flow to charge the coil. On the oscilloscope pattern it shows the current rising sharply to 7.24 amps. This shows that the coil is being charged quickly and is then flattening off as the coil is saturated. It is then being controlled by the ECU and switched off abruptly to ensure a very quick collapse of the magnetic field, in order to generate the secondary ignition voltage.

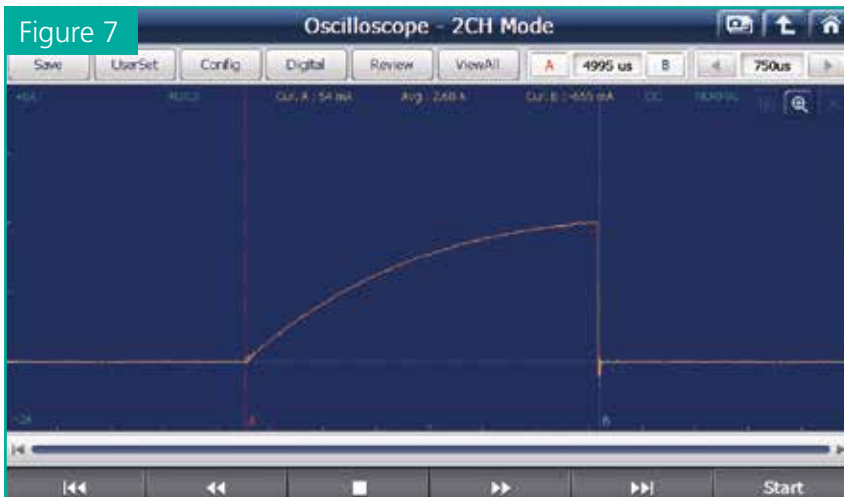
Figure 7

On measuring the suspected faulty coil for cylinders 1-4 the dwell time was the same, but the coil was slower to charge and it only had a peak of 4 amps. With this information I concluded that the misfire was due to a high resistance in the integrated driver end stage. With this affecting the primary circuit it will then affect the secondary ignition voltage. Quoting ohms law if you have a high resistance less current will flow

I replaced the coils on the bracket (which come as a pair), carefully removing the old plug leads - No.3 plug lead was seized in the coil due to corrosion. This did not show up in any of my electrical tests, which meant it had a good contact and any resistance was not affecting the secondary ignition on that cylinder. However it meant I had to replace the plug leads as well.
