# Sensing a commercial issue...

Written by Jim Gilmour - Blue Print Technical Consultant

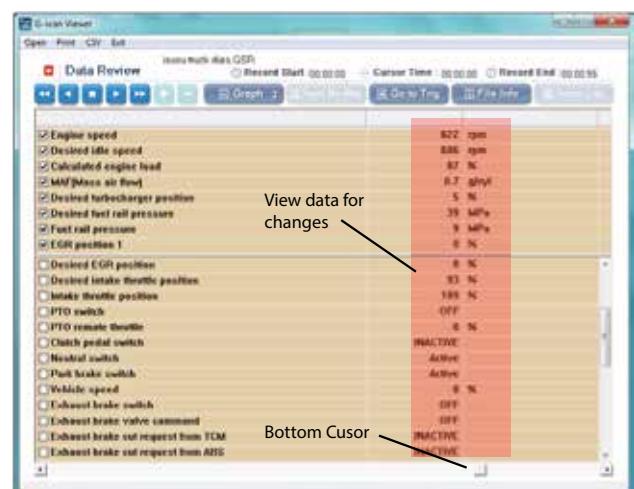
Figure 1

There are 48 parameters on this engine, so to quickly get a picture of what was going on, the G-Scan 2 was set to record all parameters and the engine was started. Fortunately I did not have to wait too long – after about 30 seconds of normal idle the engine began to surge, then faltered and stalled.

Here's what I found: (figure 1)

Data Review

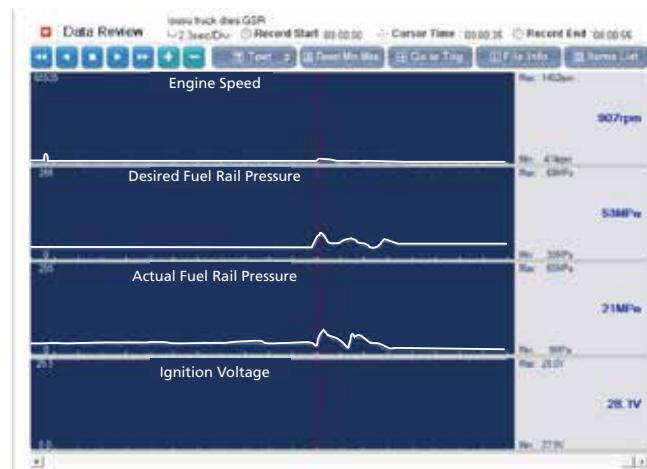
Figure 2

By sliding the bottom cursor I navigated to where the engine started to falter and the flurry of data changes drew my attention to the fuel rail pressure, I then selected the data that I wanted to look at in graph form (Figure 2). There were some very obvious discrepancies in actual and desired rail pressure.

Graph Form

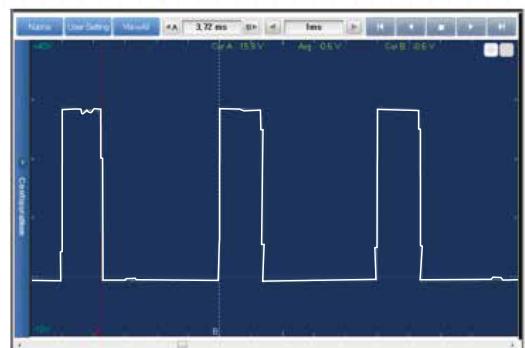
The engine control module controls the SCV by varying the duty ratio ('on time' as a percentage of the period), the SCV is a normally open type meaning that when disconnected it is fully open, maximum delivery is achieved and pressure is increased. The on time of the duty cycle controls the closing of the valve so the longer the on time the lower the fuel pressure. The scope is connected to the switched ground wire; consequently the on time is when the solenoid is switched to ground. Figure 4 shows the duty ratio when the rail pressure was maintained at a normal idle pressure of 300 bars. Figure 5 shows the duty ratio commanded to increase to try and compensate for loss of fuel pressure, causing the engine to die. The two images also show the SCV control signal and the ground to be good. The SCV windings were checked for resistance and insulation and were within specification.

Based on the information I had, I concluded that the SCV was sticking, which caused the erratic fuel pressures recorded by the G-Scan 2.

A new SCV was ordered and fitted which cured the problem completely.
