# Blue Print ADT36853

Toyota Avensis II (2003-2011),  
Corolla IX (2000-2009)

## Suction Control Valve

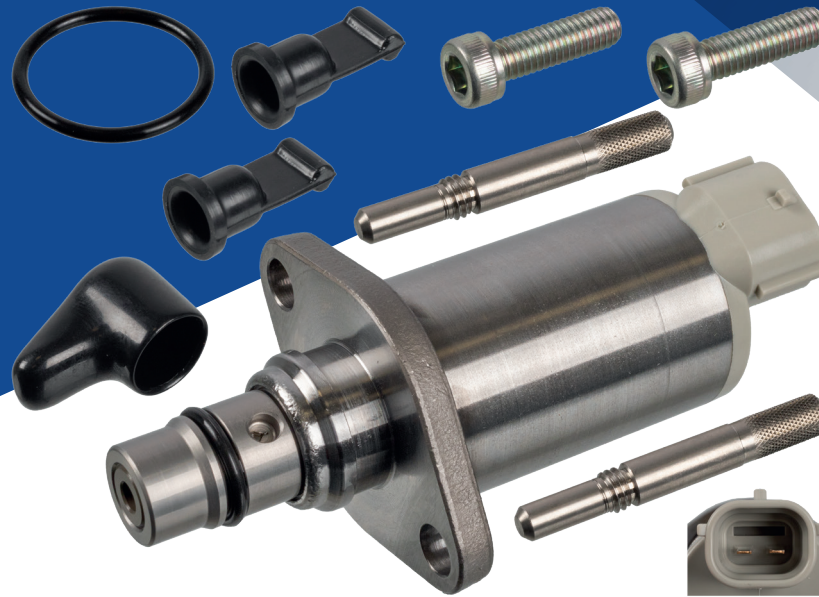
The engine surging, erratic idle, and a sudden lack of power, all of this can be intermittent. The engine fault codes logged relate to fuel rail pressure deviation.

The Suction Control Valve (SCV) solenoid has extremely fine tolerances within its moving parts, which are quickly affected by dirt and/or contaminated fuel.

A worn or contaminated SCV will cause the high-pressure fuel pump to deliver an inconsistent fuel pressure compared to what is being requested by the Engine Control Unit (ECU). Irregular fuel pressure at the injectors can cause surging as the ECU attempts to find the correct operating fuel pressure.

fuel system can cause damage. Check the fuel system for contamination and replace the fuel filter and suction control valve.

Remove the SCV, noting the connector position of the SCV to the pump. Loosen bolts and remove. Then remove the large O-ring. Install the new large O-ring to the fuel pump. Then, screw the two new guide pins into the

mounting holes and apply engine oil to the small O-ring located on the SCV before fitting to the pump.

Install the SCV by carefully pushing it into the housing. When the SCV is in position, remove the guide pins, fit the new bolts, and tighten them according to the manufacturer's tightening torque.

Once the installation is complete, carry out the supply pump learning procedure and perform a high-pressure pump test using a suitable diagnostic tool to confirm that there are no leaks and that the fuel system is functioning correctly.
