Blue Print ADBP380001

To fit:
RHD Hyundai i10 2007 > 2013

Clutch cable

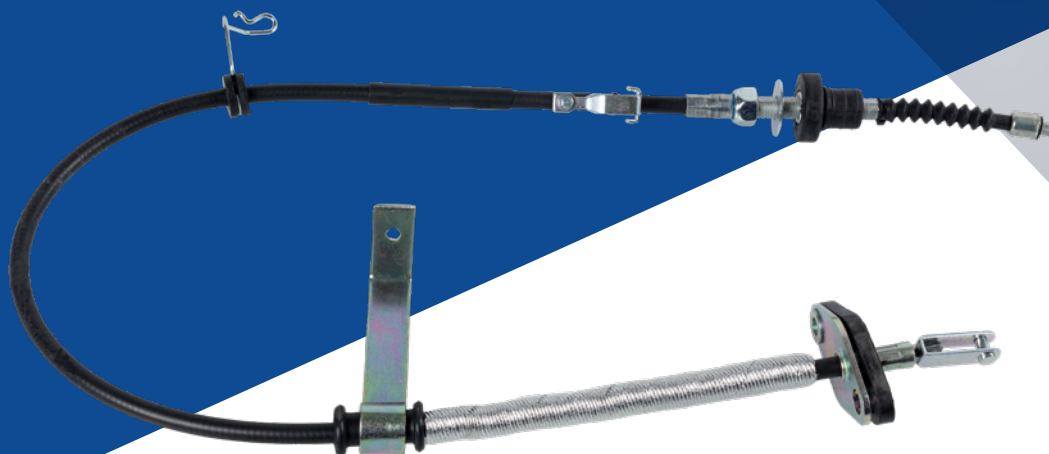
The vehicle has difficulty engaging first or reverse gear, and has an inconsistent 'biting point' when depressing the clutch pedal.

These issues can result in noise coming from the gearbox area, giving the impression of a possible clutch fault.

The clutch cable is routed around the back of the engine for right-hand drive vehicle applications. Over time, water and road debris can ingress into the cable and flush away any lubricant, which can cause rust to form on the cable. This is most notable at the end of the cable, where it connects to the clutch pedal.

Before replacing the clutch cable, check the condition of the pedal box - paying attention to the area where the pedal box is attached to the body and where the clutch cable passes through it, because it is an area known to fracture. This is due to excess stress caused by the faulty cable. The pedal box must be repaired or replaced before continuing.

Once satisfied that the pedal box is in good condition, disconnect the clutch cable and replace it with a new Blue Print clutch cable - ADBP380001.

Adjust the cable, as required, to the desired clutch pedal height of 178mm. This should be measured from the floor to the centre of the clutch pedal.

Check the 'free play' of the clutch pedal; this should measure 10-15mm before resistance is felt as the clutch pedal is depressed.

Where the clutch cable attaches to the clutch-actuating arm, this should have 2-3mm of 'free play' and can be adjusted using the barrel connector.

Check that the gearbox oil is at the correct level and top-up as necessary, then carry out a road test to check the operation of the clutch.
