Technical Bulletin

Hyundai Lantra 1.6/1.8 KF Models Only (With G4CR or G4*N DOHC engines) Caution when fitting ADC47514 Timing Belt

Date Issued: 01/07/02

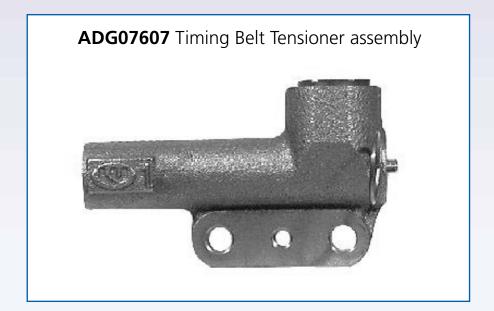
We have experienced several claims for 'timing belt failure' on the above model. Thorough investigation has identified the cause as insufficient timing belt operating tension, resulting from incorrect fitment or damage to the viscous tensioner.

Once fitted, check that the viscous tensioner protrusion is correct (3.8 - 4.8mm). LEAVE FOR AT LEAST 15 MINUTES THEN RE-CHECK THE PROTRUSION. If the protrusion has decreased, replace the tensioner.

Compress the viscous tensioner SLOWLY, otherwise the hydraulic valves inside the unit will become distorted and cause the tensioner to 'over relax' after fitment. Take two or three minutes (using a workshop vice with protected jaws) to compress the tensioner.

Blue Print recommend that the tensioner is replaced as a matter of course. If you have any doubt about the condition of the original viscous tensioner, it should also be replaced.
