Technical Bulletin

Mazda 6 Estate Luggage Cover Repair Kit

Applicable References: ADM58067

Applications: Mazda 6 Estate 2002>2008

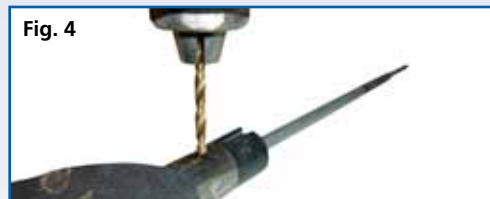
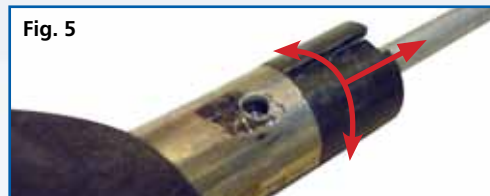
- Firstly remove the LH (passenger side) plastic cover which is retained by two cross-head screws. (Figure 1)
- Now lift the retractable cover from the housing. What you have is the leatherette cover bonded to a metal tube with a coiled spring hooked onto a plastic sleeve attached to a metal rod, running through the centre. (Figure 2)
- The plastic sleeve is located on the end that the metal rod protrudes. To enable the sleeve to be removed you must now carefully peel back some of the leatherette cover until the two indentations on the metal tube are visible. These indentations are crimping the sleeve in place. (Figures 3)
- Next you must carefully drill out these two indents using a 2.5>3mm bit. Once drilled out, carefully twist and pull the plastic sleeve to gentle ease it from the metal tube. (Figures 4 & 5)

Note: Avoid the temptation to just pull out the plastic sleeve without drilling out the indents as you are likely to damage the tube. Also, before the new sleeve can be fitted it will probably be necessary to file the inside of the metal tube to clean out any burring caused by the drilling.

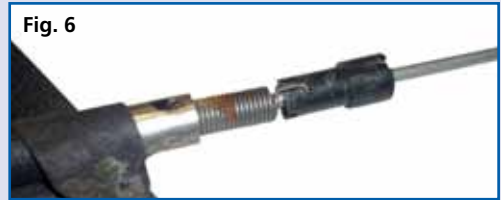
- Now the cause of the problem becomes evident. The 'L' shaped part of the plastic sleeve that the spring locates into will be worn, split or cracked. Figure 6 is of a working luggage cover, although wear is still evident so it'll only have been a matter of time!

- Withdraw the plastic clip complete with the metal rod and spring from the tube. You will see that the plastic clip was originally inserted from the other end of the rod. To remove the now 'worn out' sleeve it needs to be carefully broken off of the rod. (cut with hacksaw/crush in a vice/etc...)
