Technical Bulletin

ADM59860 - Expansion Tank

Applications: Mazda RX8

Mazda RX8 coolant light on when level is correct?

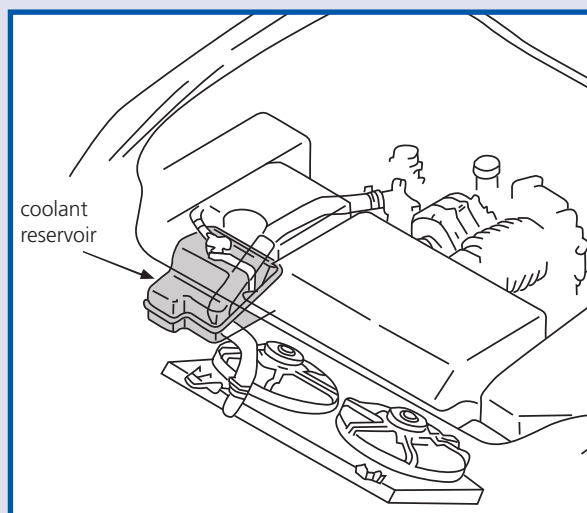
The coolant level sensor float is a common failing part on the Mazda RX8.

This is caused by surface deterioration of the sensor float which allows it to absorb coolant, causing the float to sink and give a false reading.

The sensor and float are not available separately, meaning the only permanent repair is to replace the complete Expansion Tank assembly.

Blue Print now supplies an OEM quality **Expansion Tank** with a revised specification coolant level sensor float – **ADM59860** – which is covered by Blue Print's comprehensive Three Year Warranty.

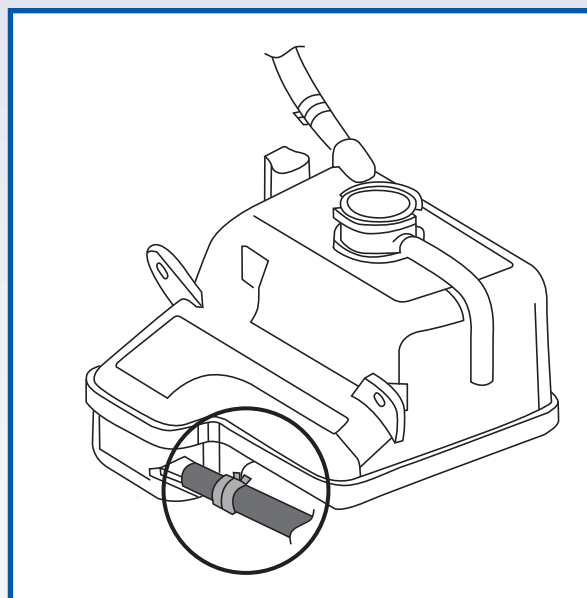
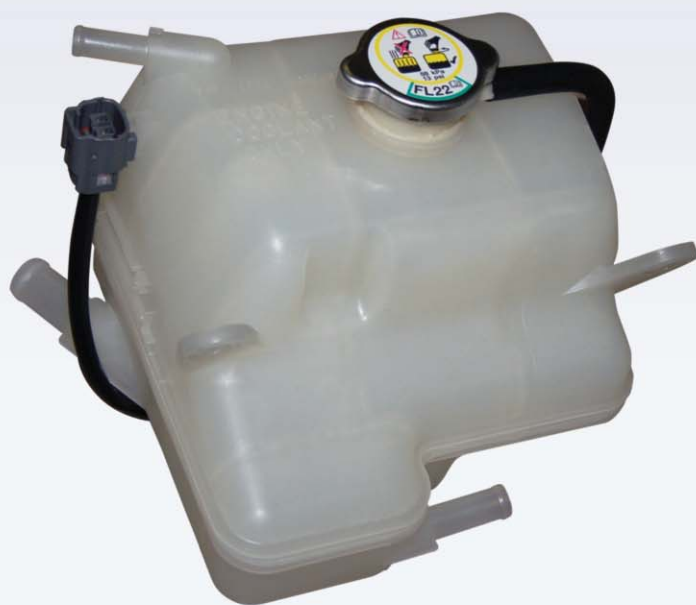
Note: Care is required when removing the coolant hose shown in the picture below, in order to avoid damage to the outlet on the radiator.
