Technical Bulletin

Mitsubishi Mainshaft Flywheel (spigot) Bearing Failure

Date Issued: 01/05/06

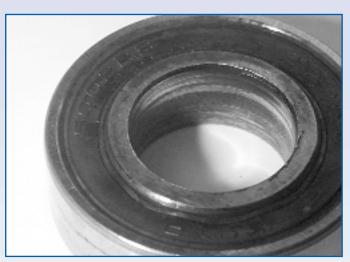
A seized flywheel bearing may cause the transmission input shaft bearing to spin and wear inside the bearing race or the outer bearing casing to spin and wear inside the flywheel.

Picture showing wear between the transmission mainshaft and the inside of the bearing inner race, due to the bearing seizure.

The bearing is pressed into the flywheel with an interference fit. Care should be taken when installing this bearing. Ensure the race is not 'pinched' when fitted.

It is advisable to replace the flywheel bearing as a precautionary measure whenever the clutch assembly is removed.
