Technical Bulletin

ADC46104C Crank Shaft Pulley

Subject - Product Information

Vehicle – Mitsubishi FTO 2.0 (DE3A)

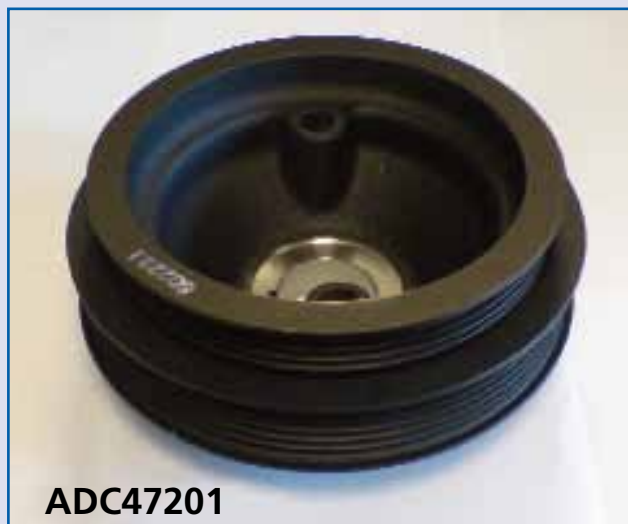
The Crankshaft pulley consists of two sections (Inner and outer), which are connected by a rubber damper.

This can in time slowly break up causing movement on the pulley.

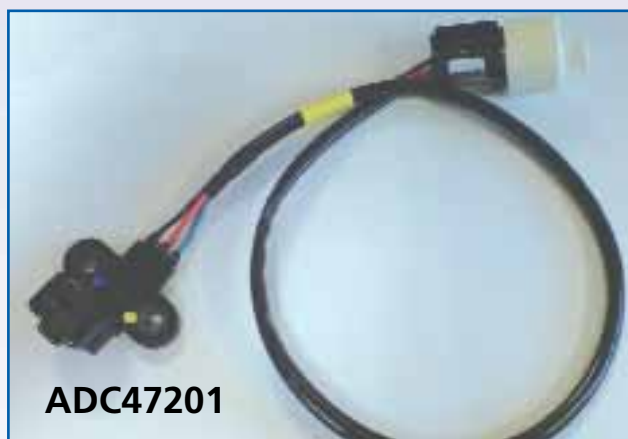
If the Crankshaft pulley is operating with a worn rubber damper at high engine RPM, the pulley can oscillate and in extreme cases there is a possibility that the outer part of the pulley can come adrift.

This excessive movement can cause the timing belt cover to move inwards and damage the Crank Angle Sensor Blade. If this part is damaged, the blade will act like a "knife" against the timing belt, with the potential of causing catastrophic engine failure
