Technical Bulletin

Ignition Coil ADC41473

Date Issued: 01/06/2005

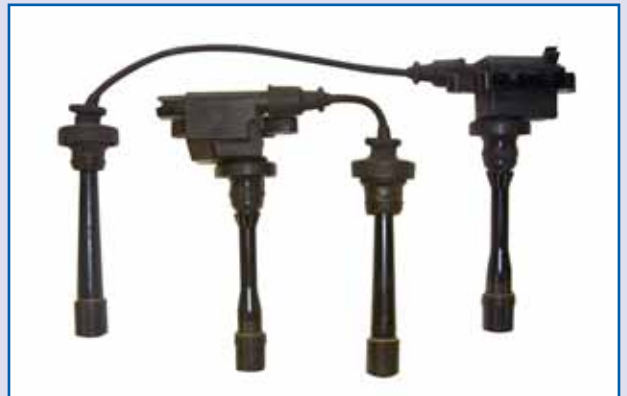
Example A was tracking from the coil body to the laminated core.

Blue Print strongly recommend that the spark plugs and HT leads are replaced in addition to the coil assembly, or that they are carefully checked. We also recommend that a logical diagnosis procedure is followed (prior to replacing the ignition coil) to prevent it being replaced unnecessarily.

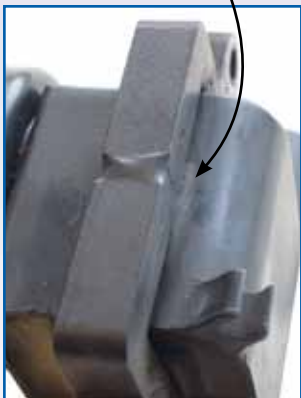
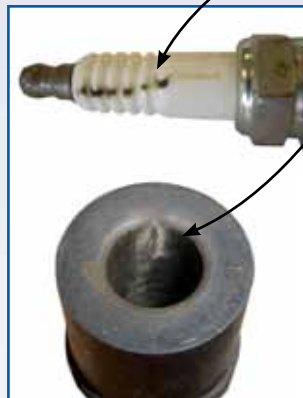
Example B shows where the spark has tracked along the spark plug ceramic (see burn marks).
