# Technical Bulletin

## Nissan Micra Alternator ADN11105 / ADN11110 / ADN11112 / ADN11113

Date Issued: 01/05/04

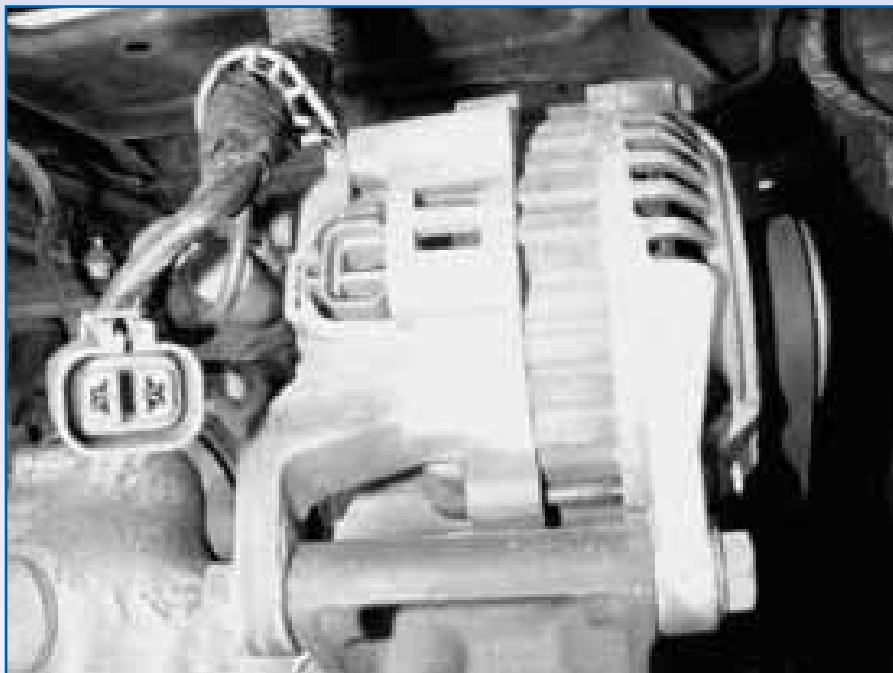
## Examples of ADN11113 on vehicle

We have experienced several instances where the above alternators have been fitted to a Nissan Micra and have appeared not to be charging the battery. Our investigations have shown that, in most cases, the problem is due to a poor connection in the vehicle wiring harness and not a fault with the connector plug on the alternator.

Please ensure that special attention is made to the condition of the harness connector terminals when fitting this unit to the Micra application and that any sign of corrosion, pitting or burning is rectified prior to its fitment. The connectors inside the harness plug should make a firm connection onto the alternator spade terminals. **PLEASE BE AWARE** - the plastic connector plug will disguise terminal 'looseness'.

If the connector terminals are found to have any of the above symptoms (or if there is any doubt as to their condition), a new terminal kit should be fitted.
