Blue Print ADV182105

Various Volkswagen, Audi, SEAT
and Škoda models.

Oil Filter

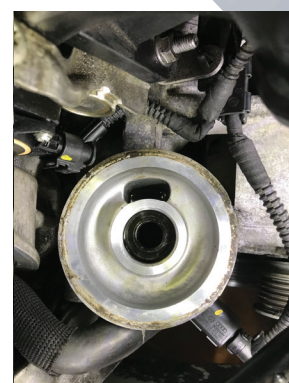
Valve installed correctly

Before installing the new oil filter, ensure the polyamide spigot valve is installed in the housing. If the valve is missing (having 'sprung' out as explained previously), find and clean the original valve, lubricate the 'O' ring-seals, and re-insert it into the housing. Alternatively, you can install a new valve - before installing the new oil filter. (Part No. 06J 115 679 E)

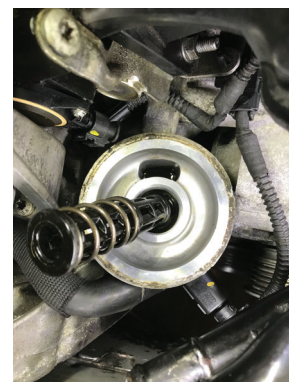
Problems can arise if the valve becomes stuck in the lower position after removing the old oil filter, which is usually indicated by the presence of 'old' oil in the housing. The spring will still be sprung-loaded and the valve can release ('spring' out) at any time. If the new oil filter is installed without the valve, the engine oil flows directly back into the sump after starting the engine. Consequently, the engine cannot reach the sufficient oil pressure - which then illuminates the oil pressure warning lamp.

Valve released

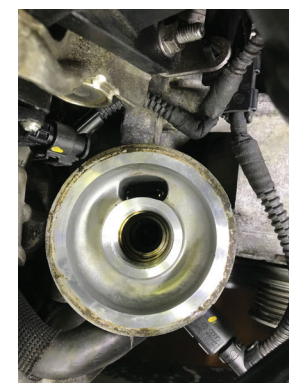
Valve missing
