Technical Bulletin

ADZ91107 and ADZ91113 Alternators

Date Issued: 01/11/01

We are aware of common vehicle faults associated with the charging system on Vauxhall applications using the Isuzu 1.5 and 1.7 diesel engines. The aim of this bulletin is to allow the correct diagnosis prior to replacing the alternator, and to assist in the prevention of further problems.

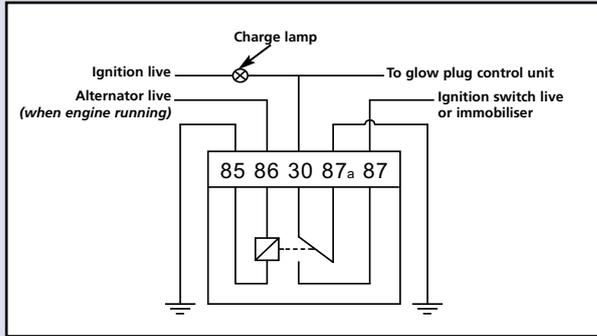
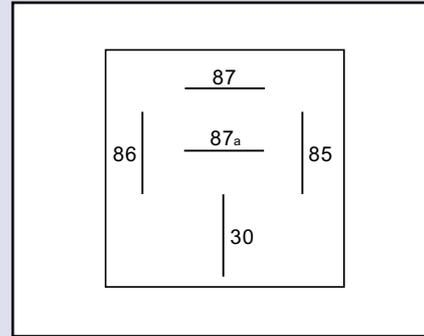
fig 1. - Charge Lamp Relay circuit

It is our experience that the Charging Lamp Relay is prone to failure. The relay controls the dashboard charging light operation and alternator excitation. It also gives a signal to the diesel system self-diagnostics and glow plug control unit for post-glow operation.

A 'quick' and simple test involves separating the round 4-pin alternator loom connector (on the driver's side inner wing - see figs 9 & 10 overleaf). With the ignition on (and the immobiliser cleared, if applicable), give a fused positive feed to the relay energising wire. This wire is normally Yellow/Red (male connector, vehicle side) and will correspond to terminal 86 at the charge lamp relay. Alternatively, apply a fused feed directly to terminal 86 at the relay (under the same conditions) to eliminate a harness fault. (see figs 1,2 & 7 overleaf).

- **We strongly recommend that the relay is changed as a matter of course when replacing the alternator, as it is possible for an internal alternator fault to damage the relay whilst in operation.**

- **If the charge warning lamp on the instrument display goes out, the relay is functioning correctly and attention should be given to the alternator and loom. If the lamp does not go out, further tests may be prudent at the relay holder.**

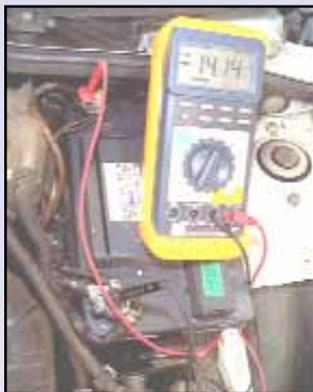
fig 3. - Charging voltage test

Test the battery voltage when the engine is running. The voltage should be between 13.7 and 14.7 volts at 1250 rpm. If it is within the above guidelines, the unit is charging correctly (see charge lamp relay test).

Please note that the battery must be in good condition and be fully charged with non-essential electrical loads switched off. A battery fault may cause overcharging, low voltage readings, or cause the alternator to 'burn out' after prolonged use.

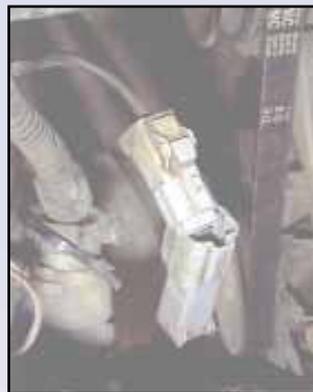
fig 4. - Main cable Lucar connector

There are two common failure points. Firstly the **large main alternator cable connector on the inner wing** is very susceptible to severe corrosion (see fig 4 overleaf of main 'Lucar' connector). Partial contact here will restrict or stop alternator charge from reaching the battery and in some cases cause the alternator to fail prematurely. This should be checked, cleaned or replaced as necessary.

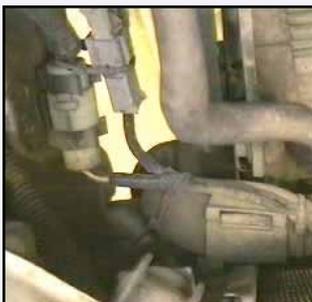
Secondly, **the wires in the alternator loom** are prone to breakage (at the alternator end). This should be tested with an Ohm meter between the inner wing connection and the alternator plug. Please be aware that the wire positions in the connectors at each end of this loom will not be the same. The rubber 'bungs' in the back of the loom connectors should be removed to show the true wire location (see fig 10 overleaf). Also, ensure that the terminals in all of the connectors are 'tight' and have no evidence of corrosion.

fig 8. - Alternator loom requiring continuity test (inner wing multi plug to alternator)

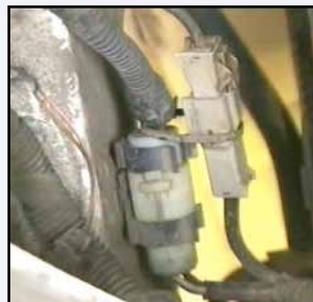
fig 9. - Position of 4-pin alternator loom and main Lucar connector on inner wing

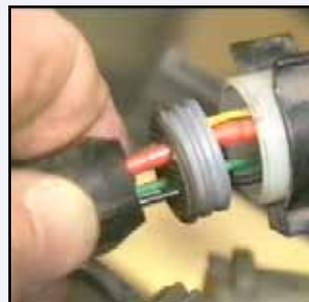
fig 10. - 4-pin connector (bung removed)
