# Blue Print ADBP250046

Toyota Prius ZVW30 & ZVW35 models

## Cabin Filter for traction battery compartment

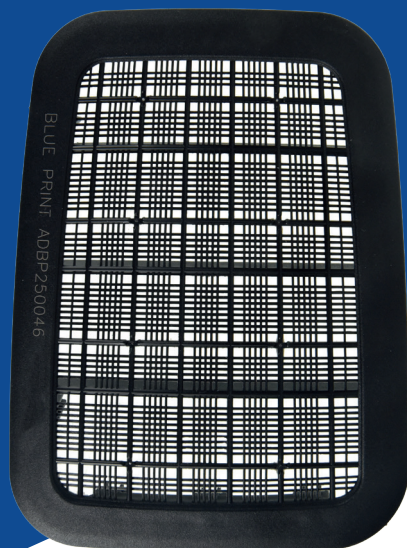
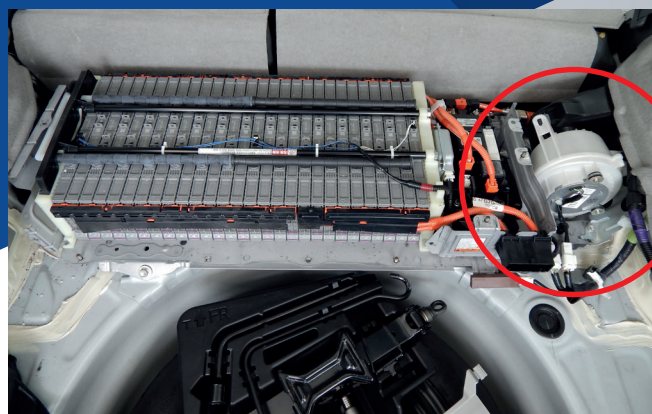
Figure 1.

The hybrid traction battery cooling fan is inoperative or provides poor cooling output.

The high-voltage battery pack is overheating. Fault codes POA82 or POA84 are logged in the battery cooling fan control module.

The most common cause of this problem is the cooling fan becoming blocked by a build-up of dirt and dust from the interior air intake located to the right of the back seat.

The Prius models mentioned above do not have an intake air filter for the high-voltage battery cooling fan fitted as standard. Instead, the fan itself becomes the filter. The fan is located upstream of the battery and collects particulates over time. (Fig.1)

Inspect the battery cooling fan for excess debris. Take off the luggage compartment flooring and right-side trim panel to gain access to the fan module, then remove it from the vehicle and inspect.

Using a vacuum cleaner and compressed air, clear away any dust, lint or debris build-up from the hybrid battery cooling fan blades, control module and air ducts of the hybrid battery cooling system.

Reinstall the hybrid battery cooling fan assembly and verify its normal operation. Repeat this procedure every 15,000 km if the vehicle is used by a lot of back-seat passengers (taxi) or is used regularly to transport pets such as cats and dogs.

It is recommended to install Blue Print filter ADBP250046, which clips over the interior air intake to reduce the build-up of dirt and dust from the interior to the cooling fan. Therefore, reducing the risk of the battery overheating and premature failure.
