Sensing a commercial issue

An Isuzu N series fleet vehicle was giving trouble while being driven. The Isuzu 3 litre four-cylinder common rail engine was fitted with a 24V electrical system, which proves no problem to either G-Scan or G-Scan 2. Blue Print Technical Consultant Jim Gilmour explains how he diagnosed and fixed the problem with the N Series truck..

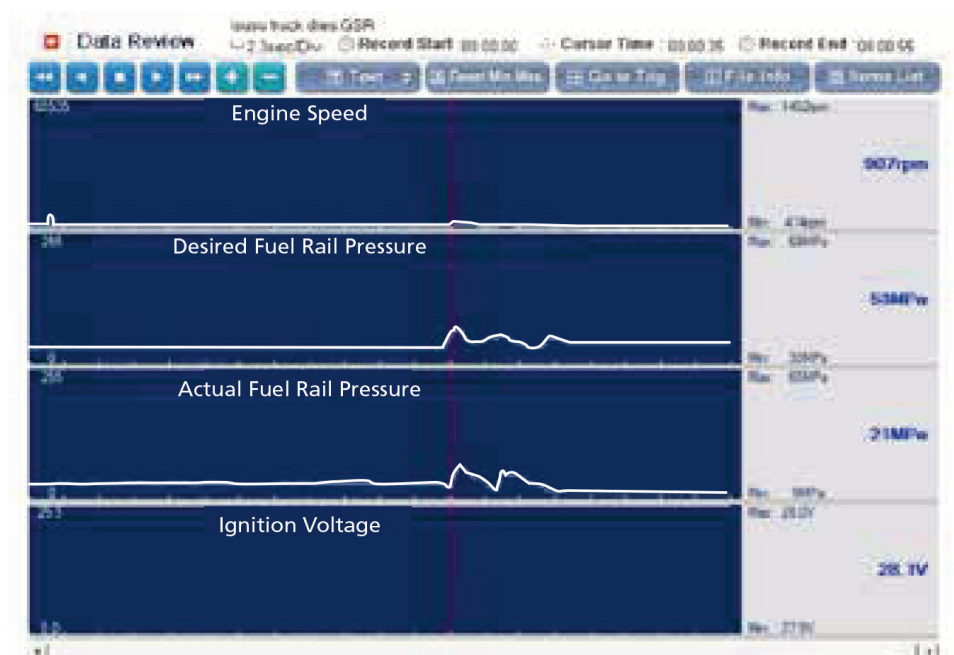
Here's what I found: (figure 1): By sliding the bottom cursor on the G-Scan2, I navigated to when the engine started to falter and the flurry of data changes drew my attention to the fuel rail pressure. I selected the data that I

Figure 1 - Discrepancies between desired and actual fuel rail pressures provided the first clue to solving the problem.

wanted to look at in graph form (Figure 1). There were some very obvious discrepancies in actual and desired rail pressure values.

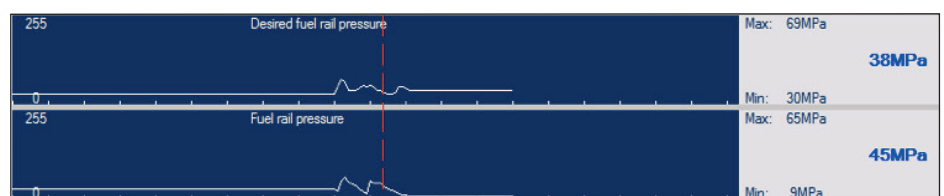
Figure 2 - The actual fuel pressure sometimes exceeded the desired fuel pressure

Looking at the relationship between desired and actual fuel rail pressure, I noticed that at times the actual pressure exceeded the desired pressure (Figure 2).

This data is unlikely to be caused by a reduced low pressure delivery volume, so my next step was to repeat the test and monitor the control of the SCV.

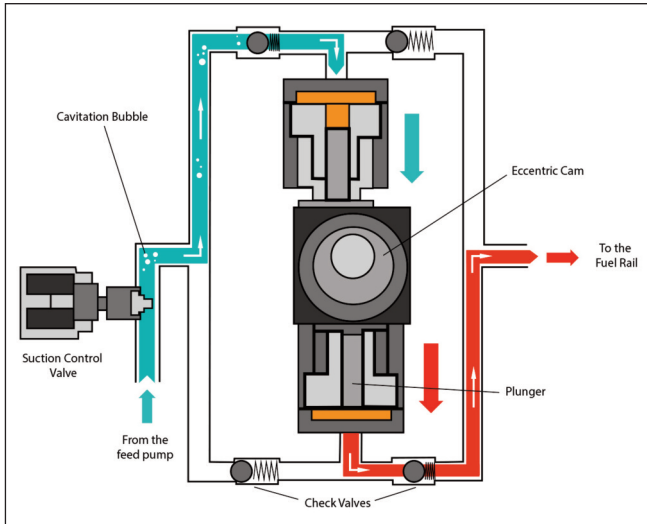
Figure 3 - The actual fuel pressure sometimes exceeded the desired fuel pressure

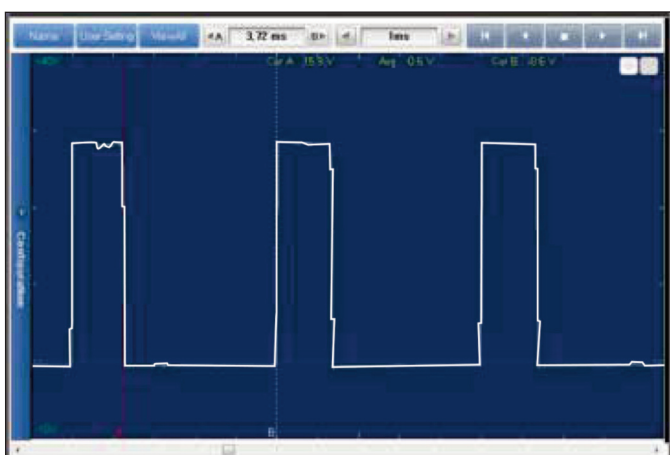
The engine control module controls the SCV by varying the duty ratio ('on time' as a percentage of the period) the SCV is a normally open type, meaning that when disconnected it is fully open and maximum delivery is achieved and pressure is increased. The on time of the duty cycle controls the closing of the valve, so the longer the on time the lower the fuel pressure. The scope was connected to the switched ground wire; consequently the on time is when the solenoid is switched to ground. Figure 4 shows the duty ratio when the rail pressure was maintained at a normal idle pressure of 300 bars. Figure 5 shows the duty ratio commanded to increase to try and compensate for loss of fuel pressure, causing the engine to die. The two images also show the SCV control signal and the ground to be good. The SCV windings were checked for resistance and insulation and were within specification.

Figure 4 - The SCV duty cycle with the engine at idle

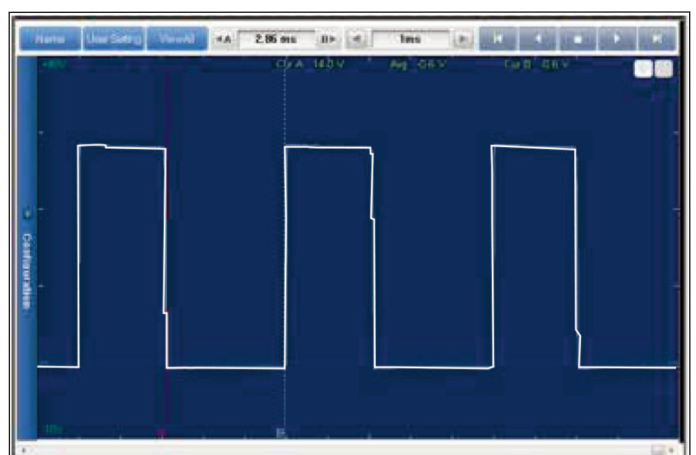
Based on the information I had, I concluded that the SCV was sticking, which caused the erratic fuel pressures recorded by the G-Scan.

Figure 5 - The SCV duty cycle increased, to try and compensate for loss of fuel pressure, causing the engine to die.

A new SCV was ordered and fitted, which cured the problem completely.
