Volkswagen Beetle - overheating cause

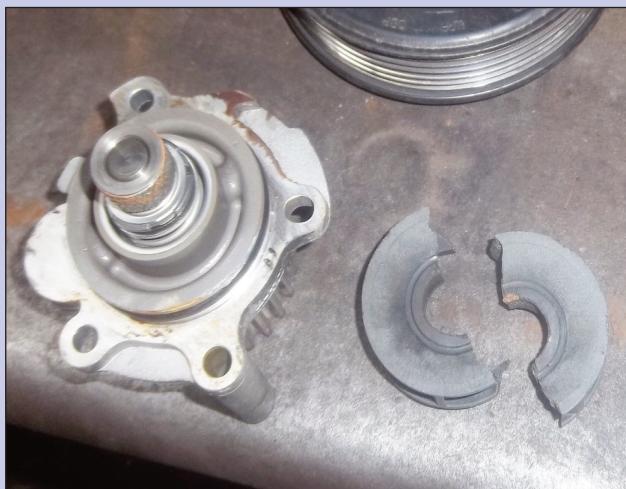
Connecting up the scanner and reading off the coolant temperature, we could see that it was running too hot at 120C. The top hose was hot and the bottom of the radiator was cool, suggesting to us a coolant flow problem. Our

The water pump impeller was in two pieces and providing no movement to the coolant

thoughts were that the water pump impeller had failed, and with the owners go ahead, we stripped off the water pump to investigate the problem.

Once the water pump was removed, our suspicions were confirmed. We found the impeller had actually split into two. With the new water pump fitted, the Beetle was once again a cool little motor.

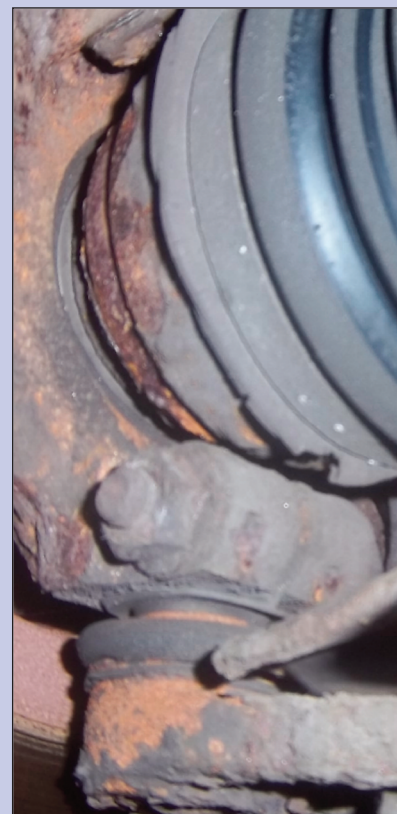
With ABS reluctor ring corroded and the CV boot perished a new shaft was the best option

A 1999 Renault Megane had been bought into us with an ABS problem, a quick code read had narrowed the problem down to the sensor on the nearside front wheel. Before ordering up a new sensor, we thought it would be wise to carry out a quick visual check.

This turned out to be a good move, and it only took a short glance to see the source of the problem was an extremely corroded reluctor ring. The corrosion was so bad that not only had the ring cracked, but half of it had fallen away from the joint.

New reluctor rings are available at a reasonable cost, but as the drive boot on this one had also perished and allowed the CV joint to dry out, we thought the quicker turnaround time of fitting a complete driveshaft was the more sensible option.

With the new shaft fitted, the ABS was now fully functional and the Renault was ready for the road.

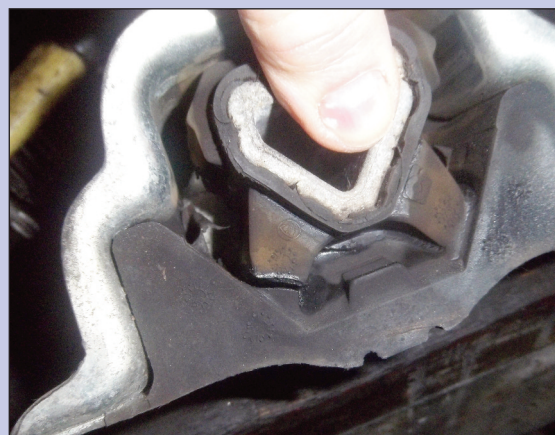
The rubber had begun to crack in the mount allowing excess movement and metal to metal contact

The constant vibration can still take its toll, causing pipes to crack and fixings to work loose. The vibration being felt through the body of this 2002 Fiat Fiorino van was beyond that which would normally be expected, especially for a van which had covered less than 50,000 miles.

The vibration was shuddering through the body of the vehicle, with a metal to metal feel in the vibration. Our first inspection was around the exhaust brackets and steady bar. All of which appeared to be good.

The next check was the engine mounts, it was at this point that we discovered that both the engine and gearbox mounts had deteriorated and were allowing the engine to drop down creating the metal to metal contact.

With the new mountings fitted, the drive and feel of the van was vastly improved.
