SMART Car - Unusual ABS Symptoms

Fiat Fiorino - Ever Decreasing Power

ROVER 25 - More than Just Heater Problems

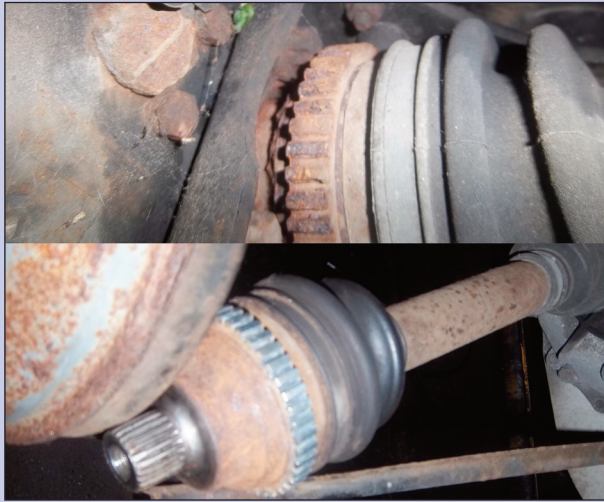
The old corroded reluctor ring was replaced with a new one curing the problem

Back at the workshop, we read the ABS codes and found that the left rear ABS sensor was showing as faulty. A physical check of the sensor proved it was not the sensor, but the reluctor ring was faulty. The ring had corroded through and cracked, allowing it to begin to spin at the magic 55 MPH. This was sending the traction control into a tizzy, causing the power to the engine to be cut as the car was thinking it was going out of control.

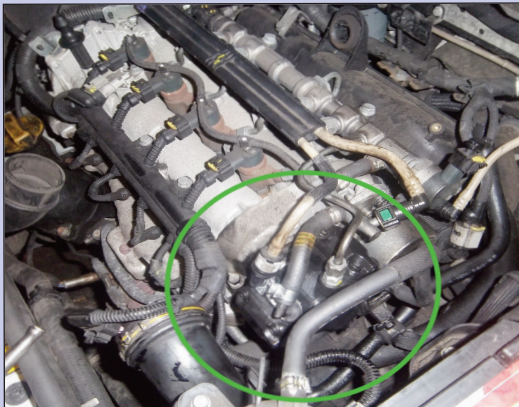
Although the van did reach our doors under its own power, by this time, things had progressed and the engine was barely able to propel the van along. A quick look with the diagnostic scanner revealed low pressure at the injectors and after a close inspection, fuel was seen escaping from the high pressure pump.

The job of replacing the high pressure fuel pump is not a difficult one

The pump is easily accessible and after letting the motor sit for a short while, to allow the remaining pressure in the system to dissipate, we set about removing the old unit. Fitting a new fuel filter in the system, along with the new high pressure pump, we then bled out the low pressure side and fired up the engine.

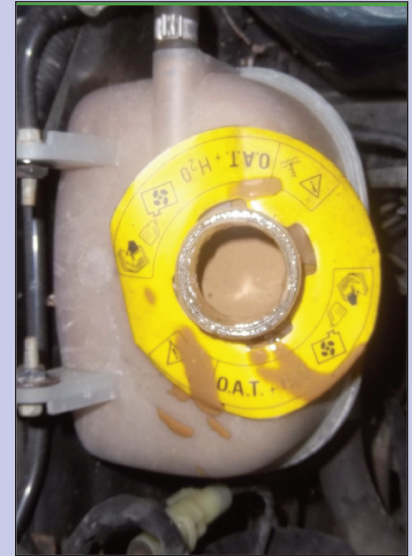
The sludge in the expansion tank was the cause of the heater not working.

The coolant expansion bottle was full of a thick, brown, emulsified liquid. This is not uncommon to see in the K series engine, and certainly the result of engine oil mixing with the coolant due to a failure of the silicon track in the head gasket.

The thick fluid that was now inhabiting the cooling system was not allowing coolant movement through the heater, hence the lack of heat in the vehicle.
