## Ford Focus - exhaust fixing missing

## Fabia - solid brake pedal

## Kunifer brake pipe better than copper

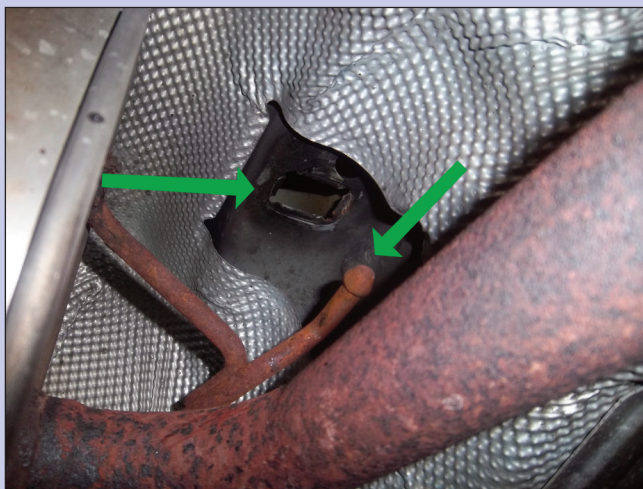
What he saw was that the rubber was totally missing and also, it appeared, was the fixing bracket! Fearing that the metal bracket must have broken away and dropped off he bought the motor in to us to sort out the problem.

The rubber was missing but the new one simply needed to be screwed into position.

the rubber did not fit on a metal bracket but was screwed into the hole he could see in the underfloor. The square end of the rubber mount, only needs pushing up into the hole and twisting 90° to secure it into position. The exhaust bracket can then be slid on to secure the pipe.

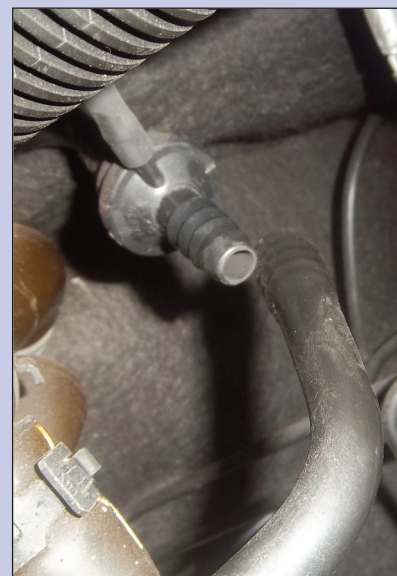
The hard plastic servo hose had failed at the joint

When we inspected the vehicle, the problem was, as we suspected, that the servo was not operating. The reason for this was not a failed servo or vacuum pump, but merely a failed servo hose.

The hard plastic servo hose between the vacuum pump and servo had hardened with age and split apart at a joint. Easily rectified, the Skoda was soon back on the road with fully operational brakes.

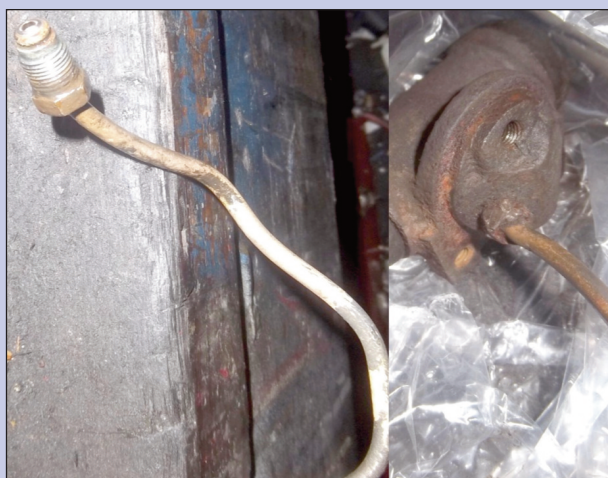
The biggest disadvantage of the copper pipe was seen on this 1998 Peugeot 406 when it came in with braking problems. The rear wheel cylinders needed replacing, but because the copper had firmly stuck in the brake union, the pipe would not come undone without twisting the old copper brake pipe.

The soft copper pipe was stuck in the union, making it impossible to remove the pipe without twisting it

vehicle, I much prefer to use Kunifer (or Cunifer as it can be spelt). This uses a mix of copper and nickel, with a small amount of iron and manganese added to give a stronger composition.

Kunifer has a far greater resistance to bonding to steel and is malleable, meaning it is easy to work with and easy to flare. It does have most of the benefits associated with copper, but unlike its copper equivalent will not work harden.
