Technical Bulletin

Toyota Estima (Lucida/Emina) 2.2DT Ancillary Driveshaft Coupling ADT38016C

Date Issued: 01/02/07

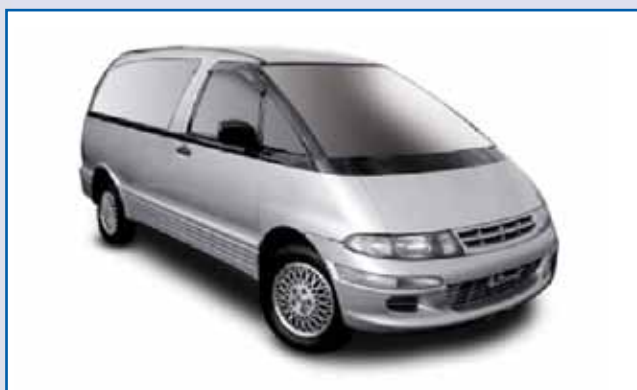
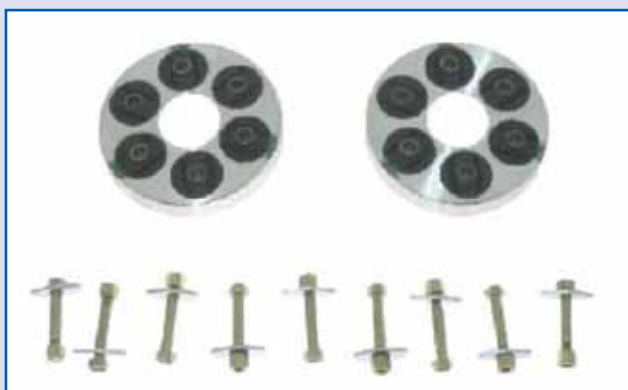
The Japanese import Toyota Estima, Lucida and Emina models commonly suffer from the ancillary driveshaft coupling failure.

The alternator, air conditioning compressor, power steering pump and cooling fan are located forward of the mid-mounted engine, and powered via an ancillary driveshaft. If the condition of the rubber and metal 'doughnut' style couplings deteriorates, it will lead to separation of the rubber from the metal carrier and rapid wear in the joints.

A worn coupling is normally associated with excessive noise and vibration at idle and should be repaired by replacing the coupling at each end of the ancillary shaft.

Blue Print supplies ADT38016C for the above applications (under 'Transmission' section) and each part will comprise of two couplings and 9 replacement bolts.

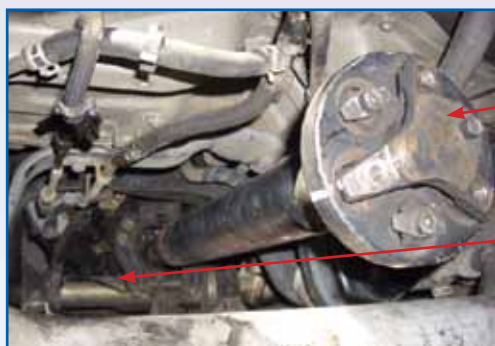
Driveshaft Coupling (engine side)

Horse shoe' carrier assembly

This picture shows the Ancillary shaft looking forward from the engine.

- Mark the shaft flanges prior to removal and refit them in the same position (to keep the correct shaft balance).
- If at all possible, do not remove the 'Horse Shoe' shaped carrier assembly which may obscure access to the front coupling retaining bolts. This should be possible using an extension bar and socket, whilst rotating the driveshaft to access one bolt at a time. The Horse Shoe carrier position is factory set for optimum alignment. If removal is necessary, take care to mark the original position beforehand.
- Remove any corrosion from the driveshaft flanges before refitting (especially engine couplig).
