# Volvo V50 Clutch Replacement

The vehicle featured in this article, is a 2011 model, fitted with the 1.6 litre diesel PSA group engine and a six-speed GETRAG manual transmission, and has stop/start, as it is a DRIVEe model.

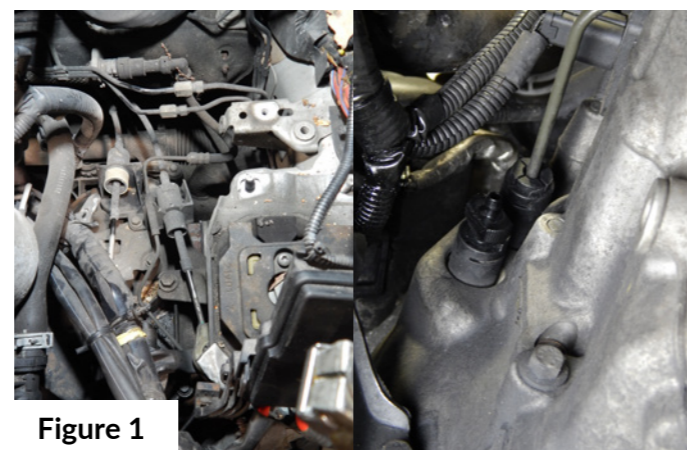
Figure 1

with the CSC hydraulic pipe connection. The open end of the connector was sealed with a plastic cap to stop any excess fluid from leaking out. (Fig 1)

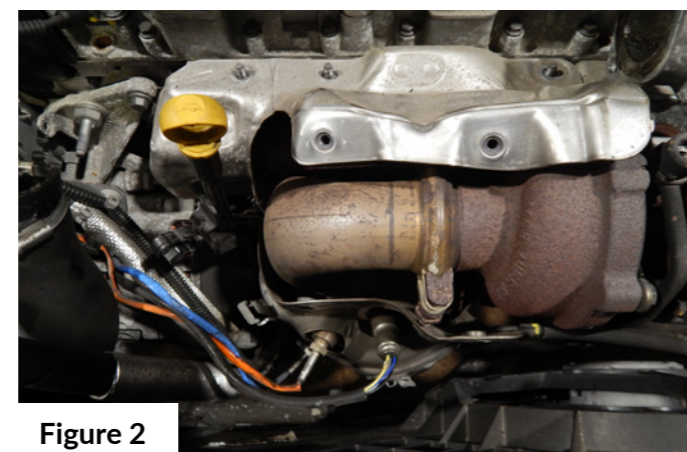
Figure 2

The diesel particulate filter (DPF), fitted to this engine needs to be lowered, in order to gain access to one of the front bell housing bolts. The temperature and lambda sensor wiring harness were disconnected and the differential pressure sensor pipes. The air intake pipe, heat shield and retaining clamp were removed, and then the DPF can be eased down to give clearance for the removal of the bell-housing bolt. (Fig 2)

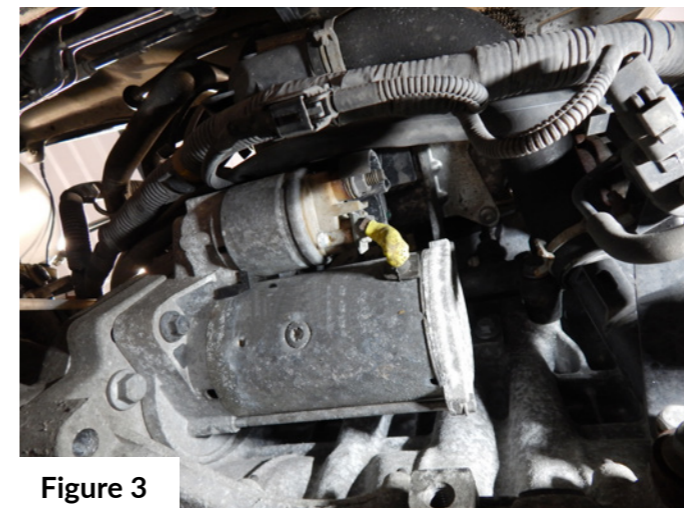
Figure 3

Working from under the vehicle, the last starter motor bolt was located and removed. The starter motor was supported and left in place because it does not need to be removed completely for the removal of this transmission. (Fig 3)

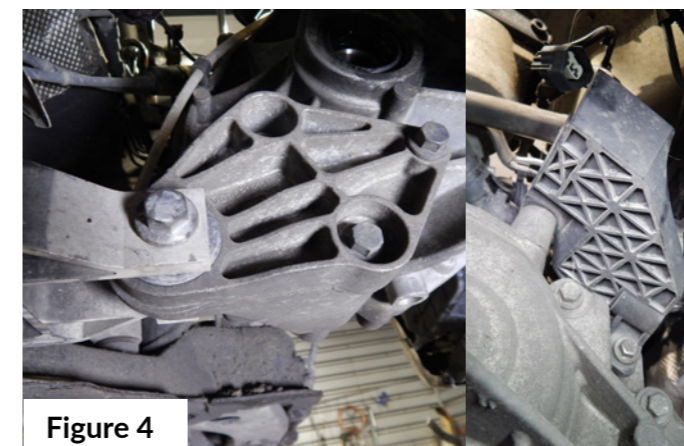
Figure 4

Next, was the removal of the gearbox torque mounting, followed by the gear selector cable bracket. This was to give extra clearance, to help when removing the transmission. (Fig 4)

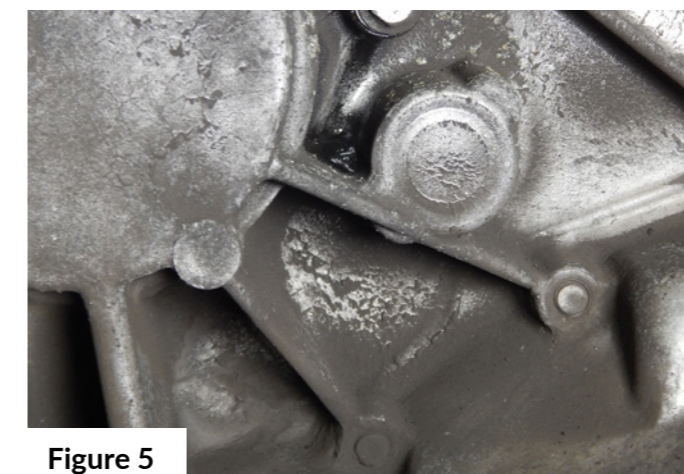
Figure 5

The engine was supported, the top transmission mount was released, and then the last of the bell housing bolts were removed, before separating the transmission from the engine. The transmission was lowered to the floor and inspected. Upon inspection of the bell housing, it became obvious that the CSC had been leaking, which was the cause of the loss of fluid in the clutch system and the poor pedal performance. (Fig. 5)

The leaking CSC was removed. Then, the bell housing and the input shaft were thoroughly cleaned of all grease, dirt and old friction fibres, from the previous clutch and the input shaft seal was inspected before fitting the new CSC (ADM53635).

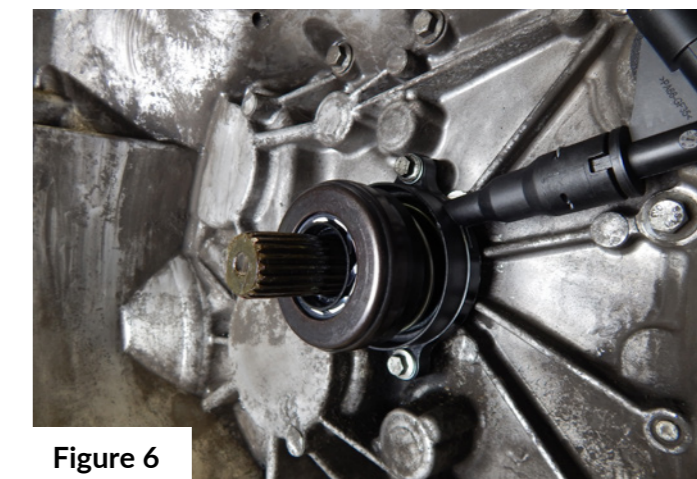
Figure 6

The transmission input shaft splines were lightly greased in preparation before installation. (Fig 6)
