# CITROËN / PEUGEOT REAR BRAKE DISC INSTALLATION

Issue Date: 03/2019 Issue Number: BRTB0004B

**APPLICATION:** Citroën C4, C4 Grand Picasso, DS4, DS5, Peugeot 308, 3008, Berlingo, Partner

**APPLICABLE REFERENCES:** BBD5841S, BBD5842S

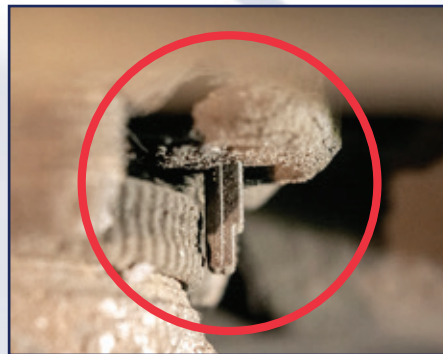
When installing new rear Brake Discs to Citroën / Peugeot applications that have an integrated magnetic seal built in, it is important that once a disc has been installed, the ABS Sensor is checked to ensure that it is located correctly, the reason being is that it is not uncommon for rust and corrosion to have affected its position, which could have an effect on the functionality of the sensor readings.

Below you can see two examples of ABS Sensors located in different positions, however the principle remains the same.

If once a new disc has been installed you can see that the ABS Sensor is contacting the magnetic reader, or the gap is not aligned correctly, then the disc and ABS Sensor should be removed, taking care not to damage the ABS Sensor. Once removed, clean the rust and corrosion from the ABS Sensor seating location. When sufficiently cleaned and correctly seated, with the disc re-installed, you will be able to see a clear 1-2mm gap.
