Technical *Info*

Installation of the drive belt kit CT 919K1/K3/K4/K5 for an Audi A4,1.8 20 V (refitting on the hydrospanner of vehicles built before 1998)

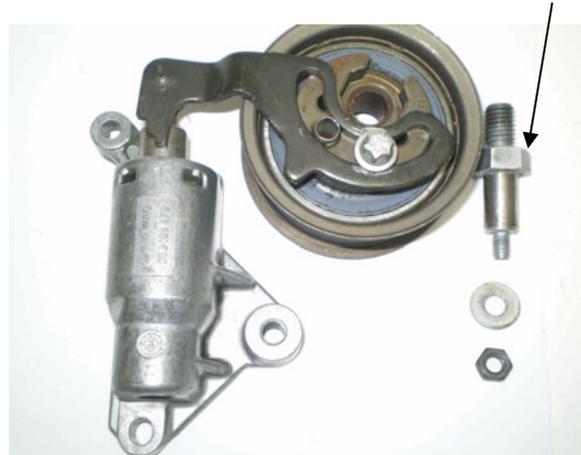
Fig. 1

The belt drive makes noises after operating for a short time,

The newly installed tension roller is not the correct distance from the engine and allows the belt to rub at the side on the inner flanged wheel. (set back)

The version to be replaced (1)

When refitting vehicles built before and during 1998, the old version stud bolt (1) must be removed. The new version is then screwed into the same hole with a pre-mounted spacer (2). The problem here is that the manufacturer has **two!!** Different thicknesses of spacer (3.1)+(3.2) which define the distance from the roller to the engine. Despite the Vehicle Identification No. delimitation (prod. month: 01/96) it is still not absolutely unequivocal which kit must be used since the stated Vehicle Identification No. can deviate from this. One should always check whether the replaced tension roller is mounted aligned in the belt drive. There will definitely be noises produced otherwise or even grave damage to the engine.

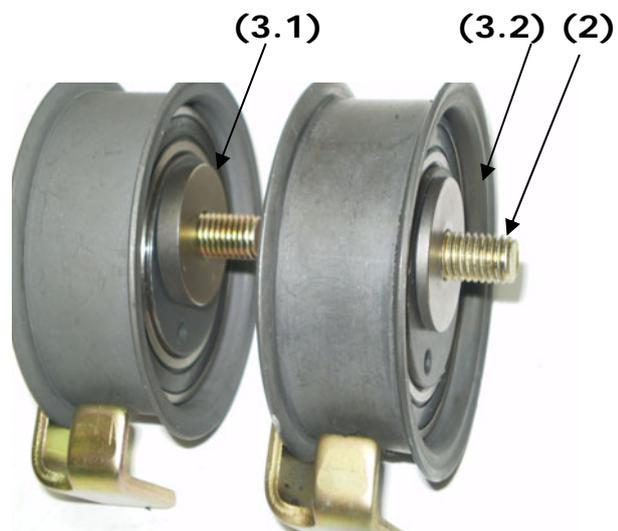
Fig. 2

New tension roller engineering
