Technical *data*

Failure of the idler pulley from CT 941K1 due to overheating Mitsubishi 1.8 GDI, Volvo V40/ S40 1.8

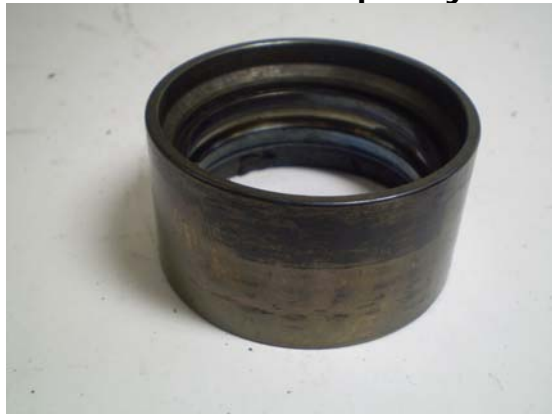
Shortly after the kit has been installed, the **idler pulley** fails due to degradation/overheating. (Fig.1)

Fig. 1
Disassembled idler pulley

The tension pulley must absolutely be clamped **counterclockwise** when an eccentric is used for clamping. The roller must be able to move freely on the assembly stand.
The tightening torque of 48 Nm on the fixing screw must be observed.

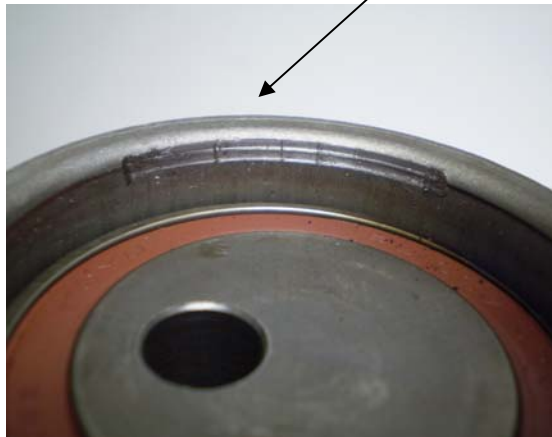
Blockage of the **tension pulley**.
This causes the belt that transmits heat to the idler pulley to overheat. As a result, the plastic cage of the bearing melts, causing the roller to fail. The blockage of the **tension pulley** occurs when the roller rubs against the assembly stand. (Fig. 2)

Fig. 2
Tension pulley inside mech. blocked
