**Noise from the timing belt drive, timing belt torn, engine damage.
CT1078K1, CT1178K1 for Opel / Vauxhall / Chevrolet 1.7D/CDTI (A17
DT/DTC/DTE/DTF/DTI DTJ/DTR/DTS, Z17 DTJ/DTR)**

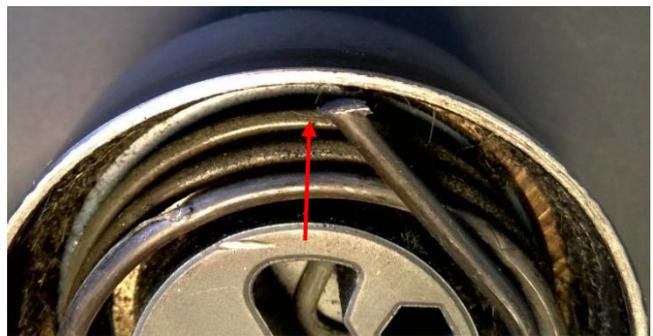
Noise from the timing belt drive. The timing belt jumps or is torn.

One edge of the timing belt is worn down along its entire length. The tensioner pulley's tension spring has been partly or completely ground down.

Make sure the entire contact surface is placed flat against the engine block and that the tension spring is positioned correctly, while also following the vehicle manufacturer's fitting instructions.
