## Risk of mixing up the tensioner and deflection pulleys in the CT1038K1 and CT1038K2 kits during fitting

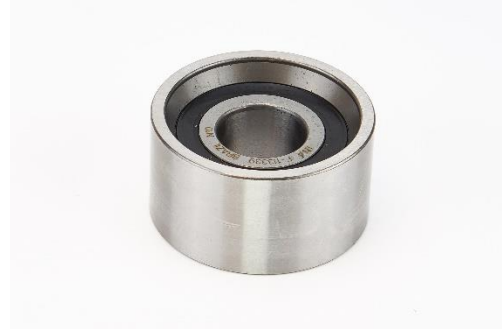
V55822 63.7 x 39mm

The deflection and tensioner pulleys are mixed up during fitting, resulting in incorrect tensioning. This can lead to increased noise and even engine damage.

The two pulleys look almost identical with only a small difference in diameter. As a result, it is easy to mix up the two pulleys.

The deflection pulley V55826 has a diameter of 67mm. The tensioner pulley V55822 has a smaller diameter of 63.7mm.
