Technical *Info*

CT 1096 K1 timing belt kit taking as an example: Rover / MG all 2.0 / 2.5 V6

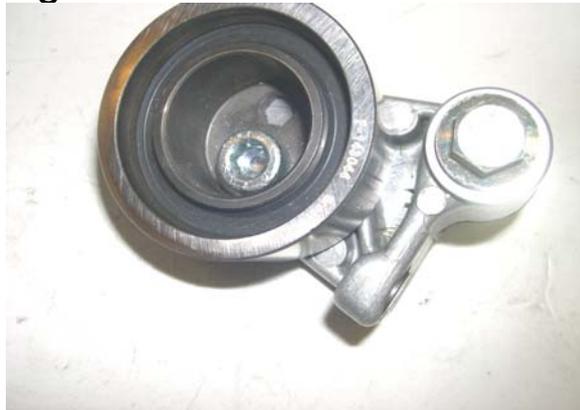
Fig.1

The tension roller (Fig. 1) twists on the base frame during operation. During further operation, the running surface starts to contact the base frame and becomes blocked. (Fig. 2)
> The motor can be damaged!

After the timing belt has been installed and **adjusted**, the roller must be **finally fixed** by tightening the mounting bolt with 40 -50 Nm.

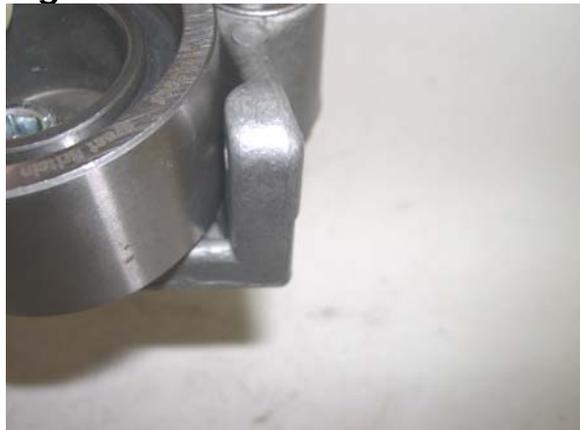
Fig.2

You must ensure that the roller is only **pre-mounted** to the base frame with 10 Nm
